Defect Listing

Pipe Segment Refere... E6-1_E4-3	City Oliver Springs	Street Easement	Material Other	Location C... Easement/R...	Sewer Use Sanitary
Upstream MH E6-1	Total Length 158.8	Year Laid	Shape Circular	Location Details Runs from Gail Ln t...	
DS Manhole E4-3	Length surveyed 158.8	Year Renewed	Height 8	Width 8	Pipe Joint... N/A

SPR N/A	MPR 2	PO Number 4397-03		Customer GRW	
SPRI N/A	MPRI 2	Work Order 4397-02		Purpose Pre-Rehabilitation Survey	
QSR N/A	QMR 2100				
OPR 2	Surveyed By Barry Rogers	Direction Downstream	Date 20150617	Media label	
OPRI 2	Certificate Number U-1012-16405	Pre-Cleaning Heavy Cleaning	Time 14:29	Weather Very Dry	
Date Cleaned 20150617			End Time 14:38	Additional Info

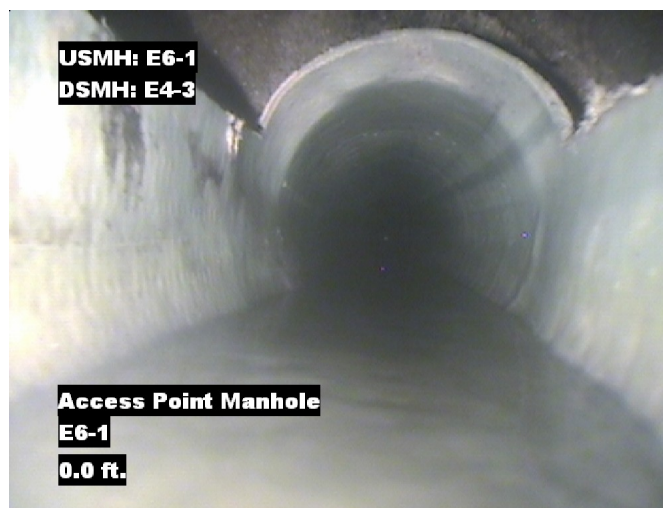
Distance: 0.0 ft. Grade: 0
Condition: Access Point Manhole
Remarks: E6-1

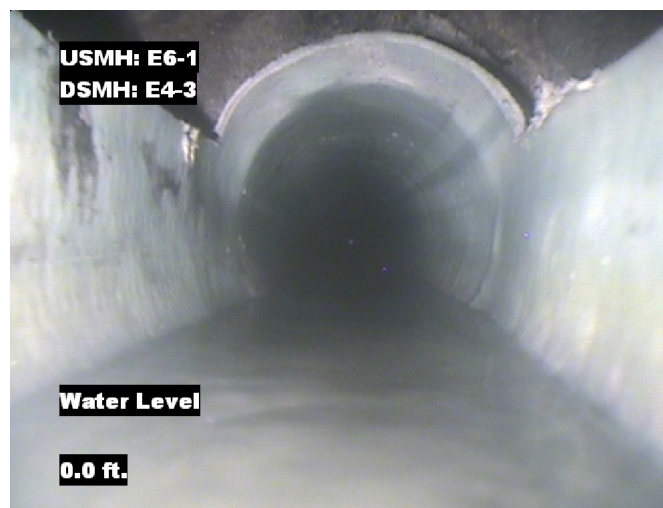
Distance: 0.0 ft. Grade: 0
Condition: Water Level
Remarks: N/A

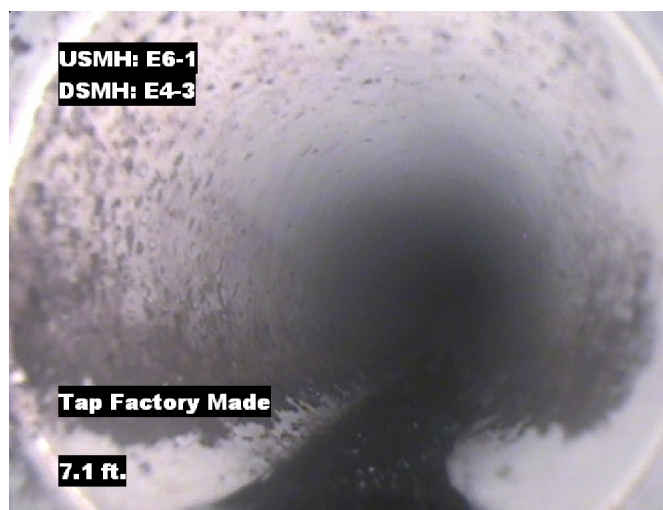
Distance: 7.1 ft. Grade: 0
Condition: Tap Factory Made
Remarks: N/A

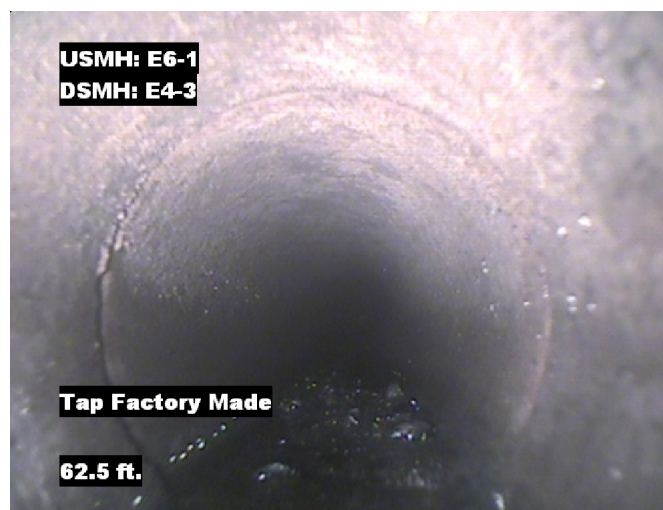
Distance: 62.5 ft. Grade: 0
Condition: Tap Factory Made
Remarks: N/A

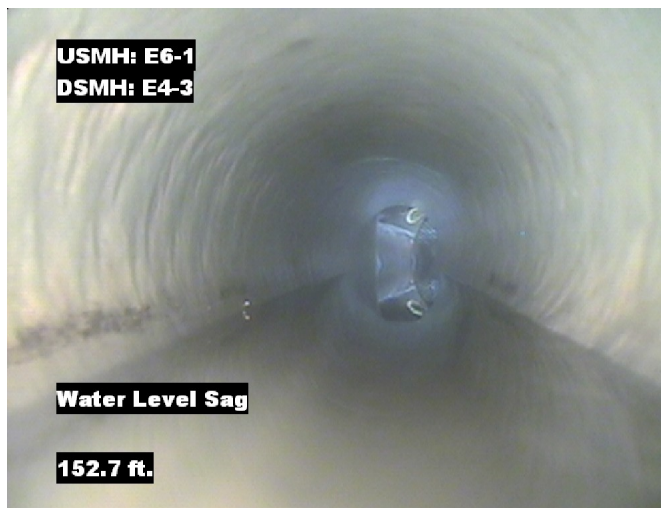
Distance: 152.7 ft. Grade: 2
Condition: Water Level Sag
Remarks: N/A

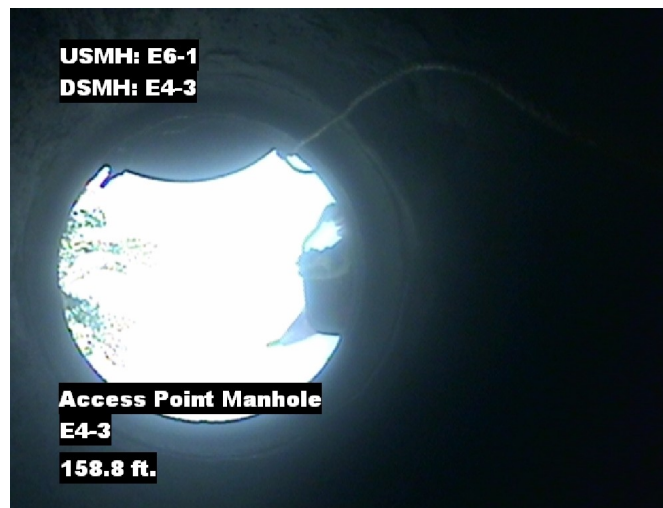
Distance: 158.8 ft. Grade: 0
Condition: Access Point Manhole
Remarks: E4-3
