## Defect Listing

Pipe Segment Refere... <b>E6-2_E6-1</b>	City <b>Oliver Springs</b>	Street <b>Null</b>	Material <b>Other</b>	Location C... <b>Easement/R...</b>	Sewer Use <b>Sanitary</b>
Upstream MH <b>E6-2</b>	Total Length <b>220.3</b>	Year Laid	Shape <b>Circular</b>	Location Details <b>Runs from Gail Ln t...</b>	
DS Manhole <b>E6-1</b>	Length surveyed <b>220.3</b>	Year Renewed	Height <b>8</b>	Width <b>8</b>	Pipe Joint... <b>N/A</b>

SPR <b>N/A</b>	MPR <b>2</b>	PO Number <b>4397-03</b>	Customer <b>GRW</b>
SPRI <b>N/A</b>	MPRI <b>2</b>	Work Order <b>4397-02</b>	Purpose <b>Pre-Rehabilitation Survey</b>
QSR <b>N/A</b>	QMR <b>2100</b>		
OPR <b>2</b>	Surveyed By <b>Barry Rogers</b>	Direction <b>Downstream</b>	Date <b>20150617</b>
OPRI <b>2</b>	Certificate Number <b>U-1012-16405</b>	Pre-Cleaning <b>Heavy Cleaning</b>	Time <b>14:15</b>
	Date Cleaned <b>20150617</b>	End Time <b>14:26</b>	Weather <b>Very Dry</b>
			Media label
			Additional Info

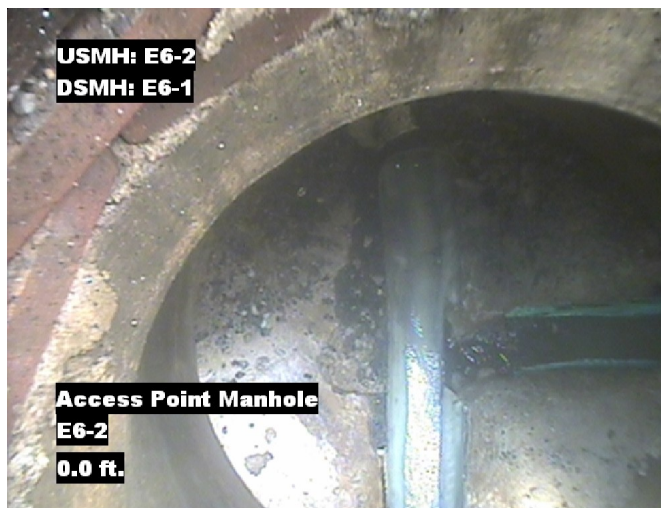
Distance: 0.0 ft. Grade: 0  
Condition: Access Point Manhole  
Remarks: E6-2

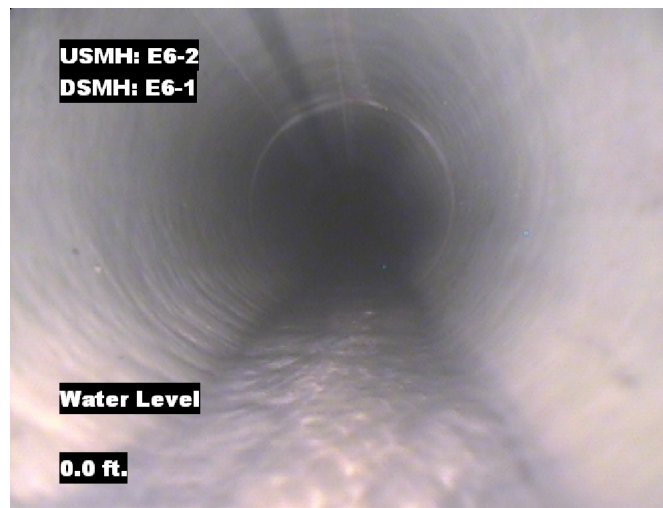
Distance: 0.0 ft. Grade: 0  
Condition: Water Level  
Remarks: N/A

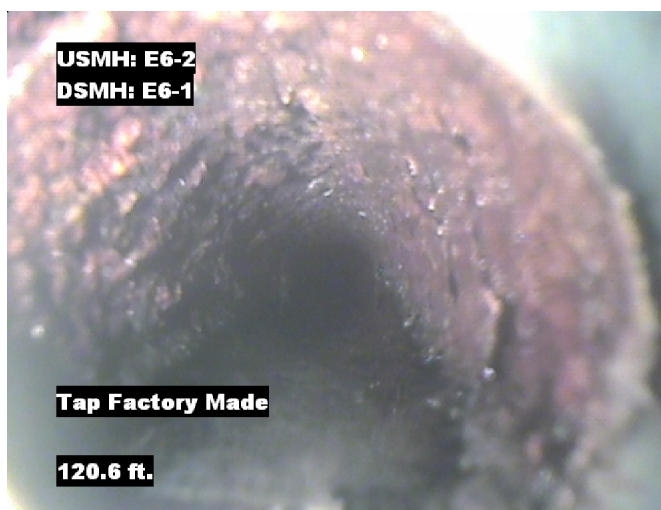
Distance: 120.6 ft. Grade: 0  
Condition: Tap Factory Made  
Remarks: N/A

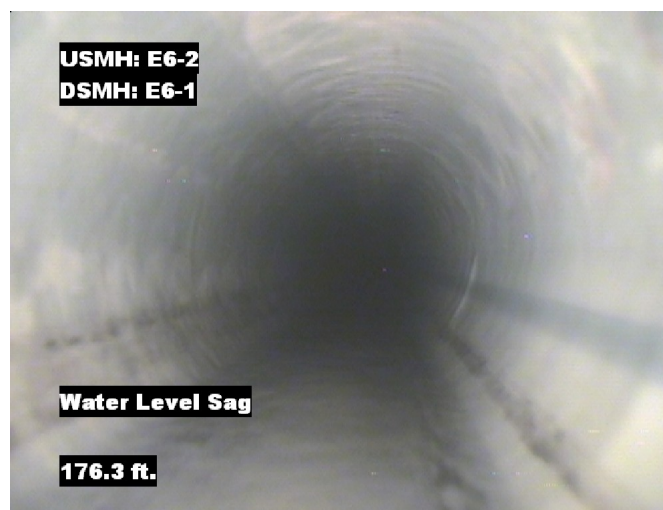
Distance: 176.3 ft. Grade: 2  
Condition: Water Level Sag  
Remarks: N/A

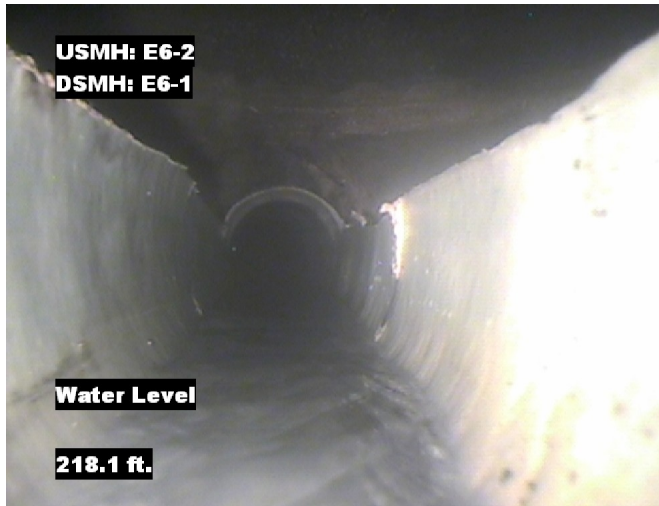
Distance: 218.1 ft.      Grade: 0  
Condition: Water Level  
Remarks: N/A

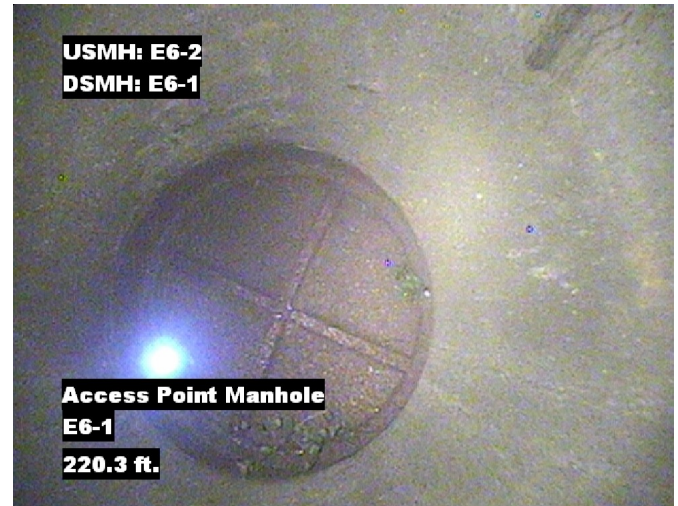
Distance: 220.3 ft.      Grade: 0  
Condition: Access Point Manhole  
Remarks: E6-1
