Defect Listing

Pipe Segment Refere... E6-3_E6-2	City Oliver Springs	Street Gail Ln	Material Fiberglass Reinf...	Location C... Light High...	Sewer Use Sanitary
Upstream MH E6-3	Total Length 10.2	Year Laid	Shape Circular	Location Details Behind Bank	
DS Manhole E6-2	Length surveyed 10.2	Year Renewed	Height 8	Width 8	Pipe Joint... N/A

Image Report 4/Page

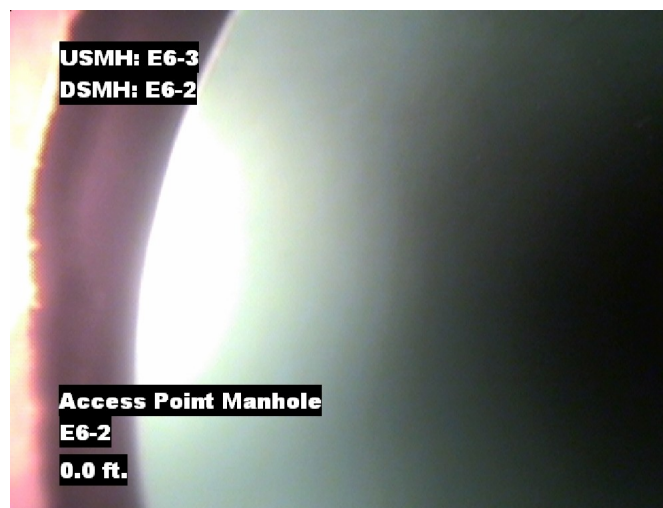
Distance: 0.0 ft. Grade: 0
Condition: Access Point Manhole
Remarks: E6-2

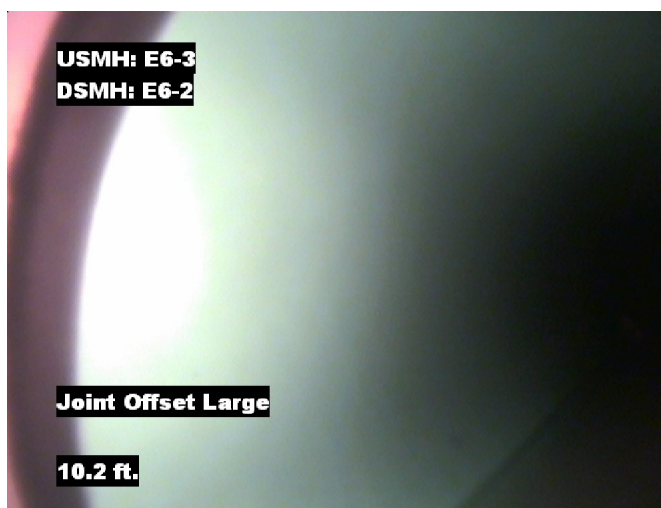
Distance: 10.2 ft. Grade: 2
Condition: Joint Offset Large
Remarks: N/A

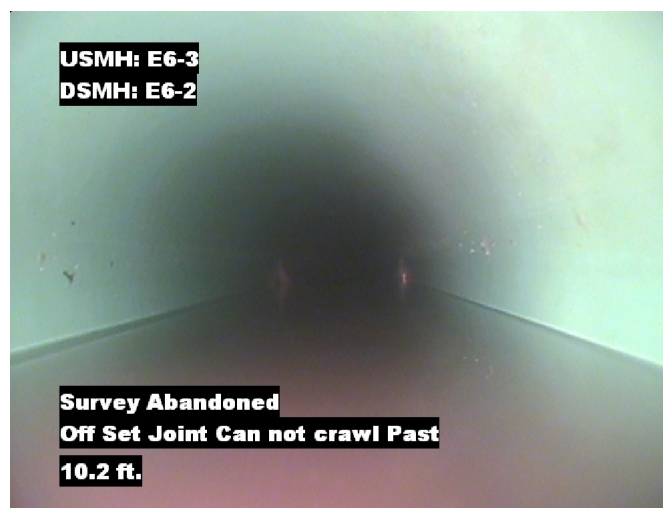
Distance: 10.2 ft. Grade: 0
Condition: Survey Abandoned
Remarks: Off Set Joint Can not crawl Past
