Defect Listing

Pipe Segment Refere... E6-4 E6-3	City Oliver Springs	Street Gail Ln	Material PolyVinyl Chloride	Location C... Light High...	Sewer Use Sanitary
Upstream MH E6-4	Total Length 290.6	Year Laid	Shape Circular	Location Details Side of Rd	
DS Manhole E6-3	Length surveyed 290.6	Year Renewed	Height 8	Width 8	Pipe Joint... 13

SPR 31	MPR 64	PO Number 4397-03	Customer GRW
SPRI 3.1	MPRI 2.1	Work Order 4397-02	Purpose Pre-Rehabilitation Survey
QSR 4139	QMR 422D		
OPR 95	Surveyed By Barry Rogers	Direction Downstream	Date 20150616
OPRI 2.4	Certificate Number U-1012-16405	Pre-Cleaning Heavy Cleaning	Time 10:32
	Date Cleaned 20150616	End Time 10:49	Weather Very Dry
			Media label Additional Info

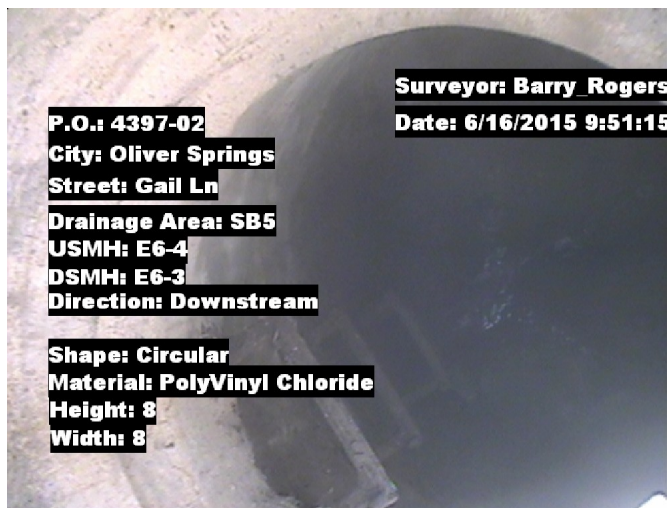
Distance: 0.0 ft. Grade: 0
Condition: Access Point Manhole
Remarks: E6-4

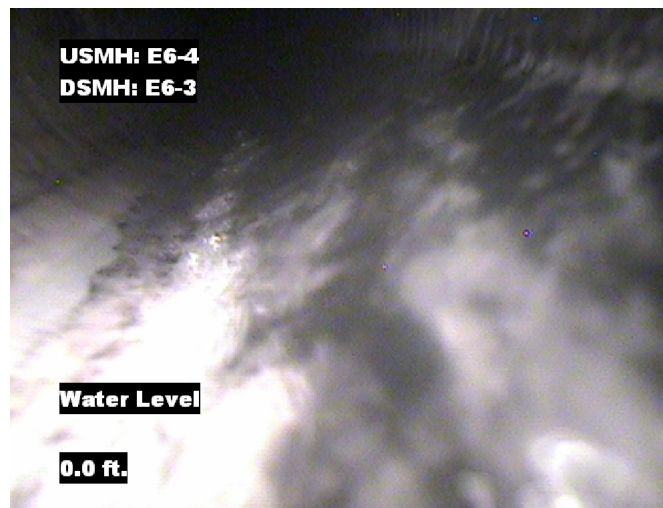
Distance: 0.0 ft. Grade: 0
Condition: Water Level
Remarks: N/A

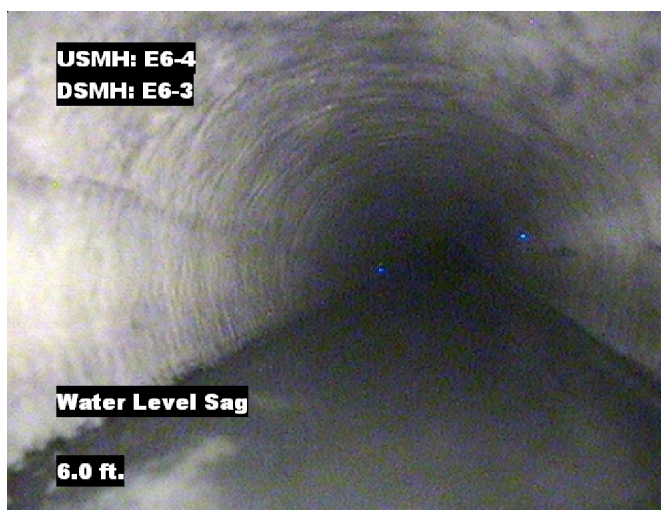
Distance: 6.0 ft. Grade: 2
Condition: Water Level Sag
Remarks: N/A

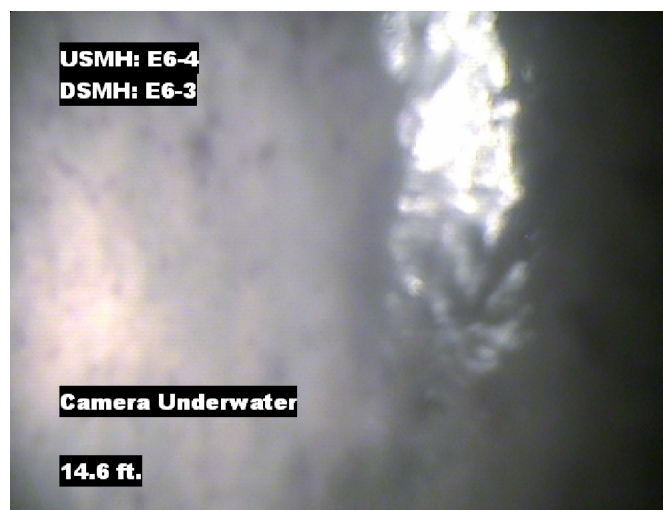
Distance: 14.6 ft. Grade: 4
Condition: Camera Underwater
Remarks: N/A

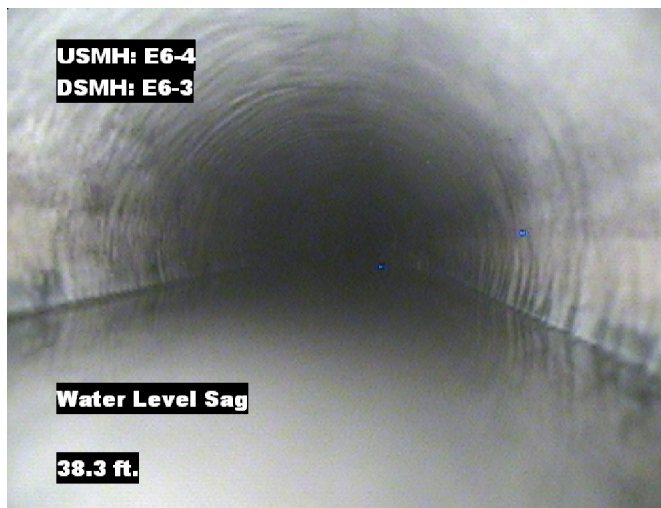
Distance: 38.3 ft. Grade: 2
Condition: Water Level Sag
Remarks: N/A

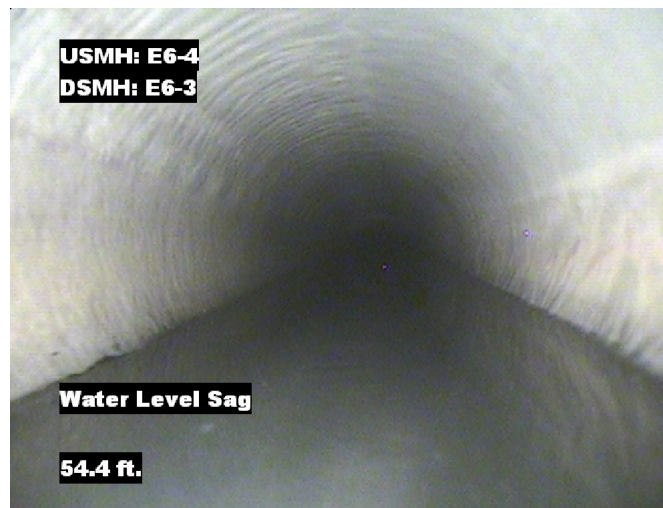
Distance: 54.4 ft. Grade: 2
Condition: Water Level Sag
Remarks: N/A

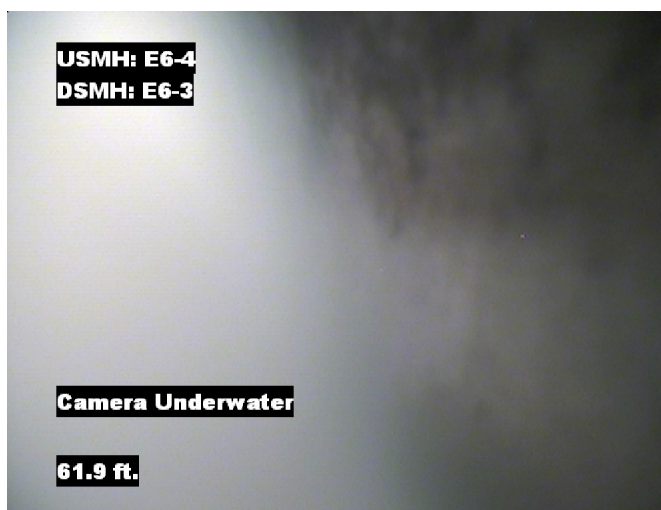
Distance: 61.9 ft. Grade: 4
Condition: Camera Underwater
Remarks: N/A

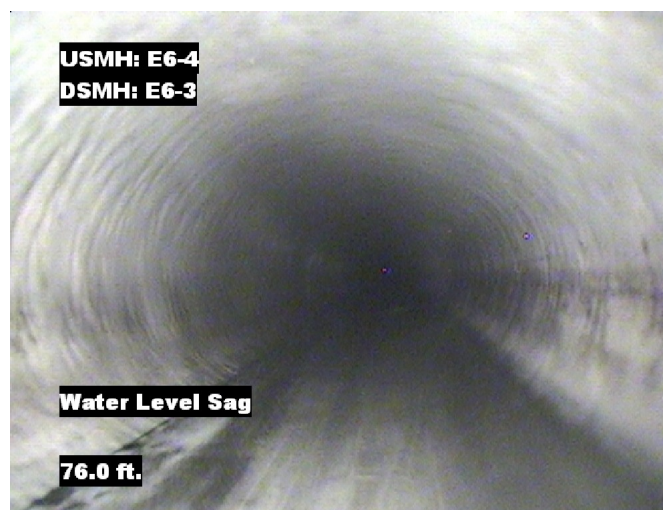
Distance: 76.0 ft. Grade: 2
Condition: Water Level Sag
Remarks: N/A

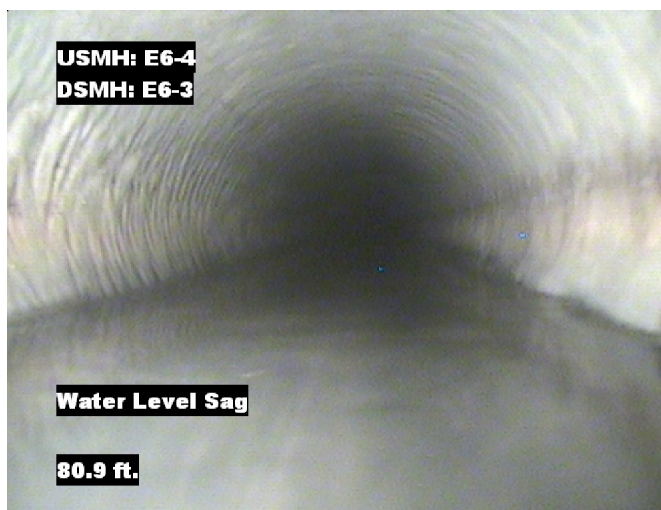
Distance: 80.9 ft. Grade: 2
Condition: Water Level Sag
Remarks: N/A

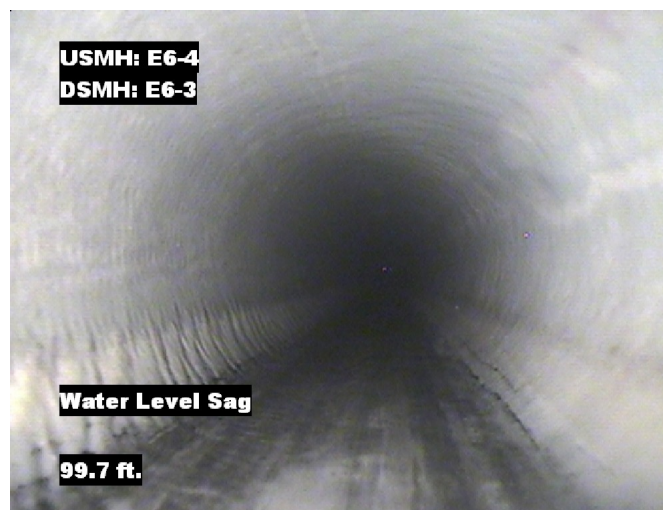
Distance: 99.7 ft. Grade: 2
Condition: Water Level Sag
Remarks: N/A

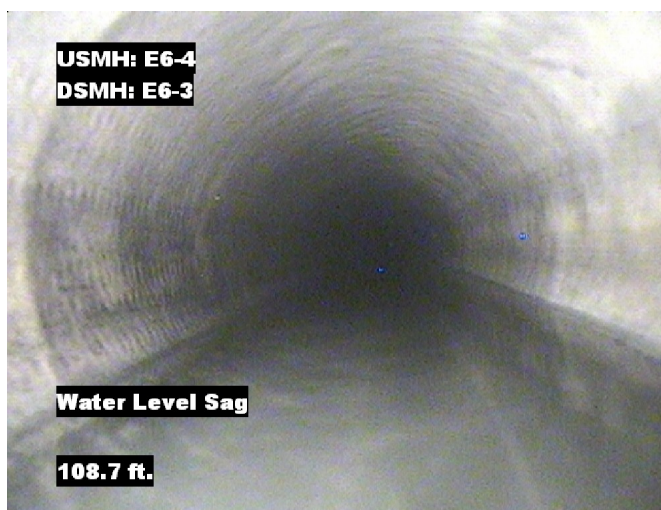
Distance: 108.7 ft. Grade: 2
Condition: Water Level Sag
Remarks: N/A

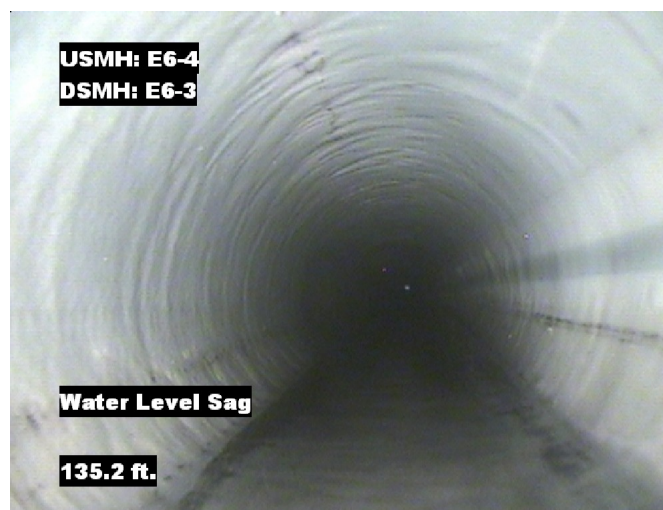
Distance: 135.2 ft. Grade: 2
Condition: Water Level Sag
Remarks: N/A

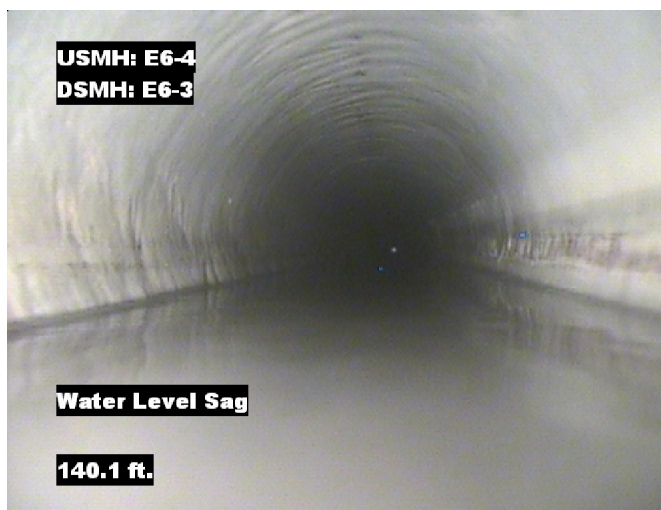
Distance: 140.1 ft. Grade: 2
Condition: Water Level Sag
Remarks: N/A

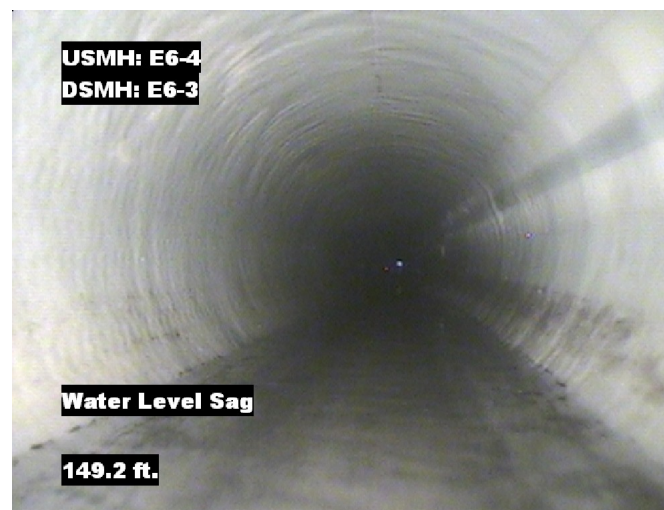
Distance: 149.2 ft. Grade: 2
Condition: Water Level Sag
Remarks: N/A

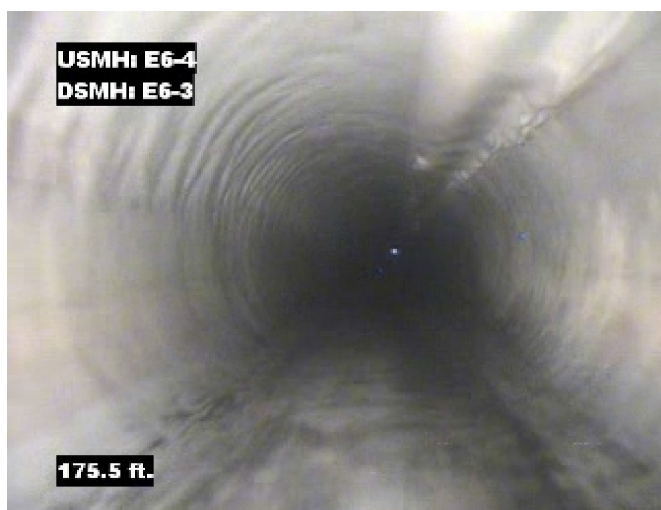
Distance: 175.2 ft. Grade: 3
Condition: Lining Failure Wrinkled
Remarks: N/A

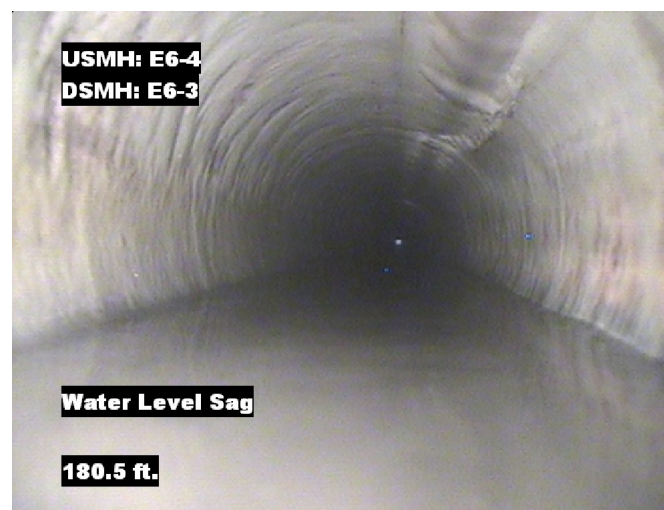
Distance: 180.5 ft. Grade: 2
Condition: Water Level Sag
Remarks: N/A

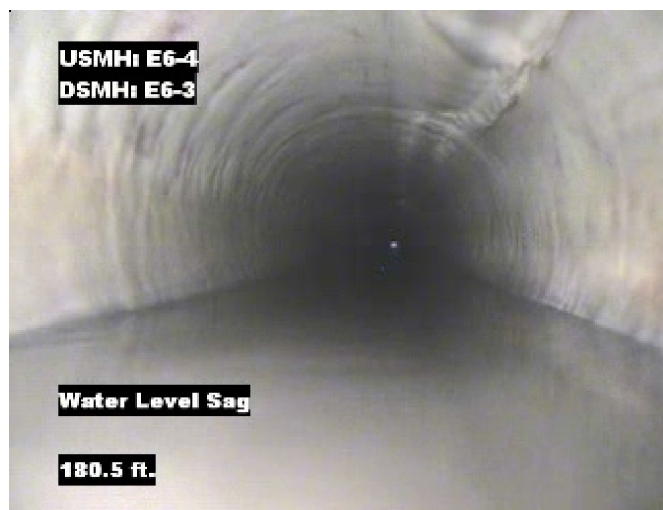
Distance: 180.6 ft. Grade: 3
Condition: Lining Failure Wrinkled
Remarks: N/A

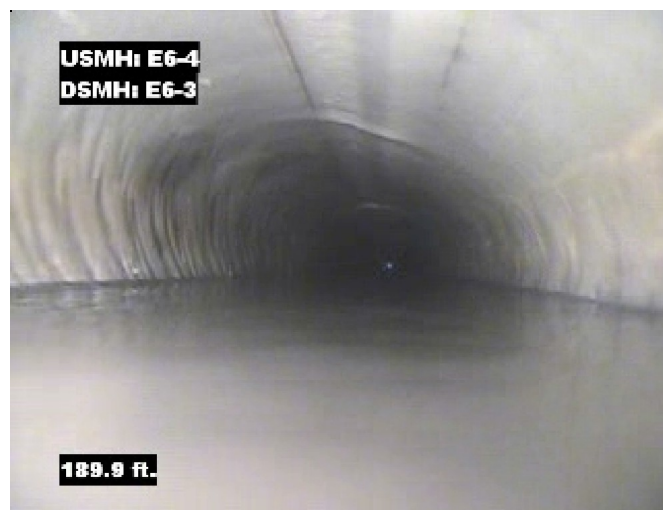
Distance: 190.6 ft. Grade: 4
Condition: Deformed Vertically
Remarks: N/A

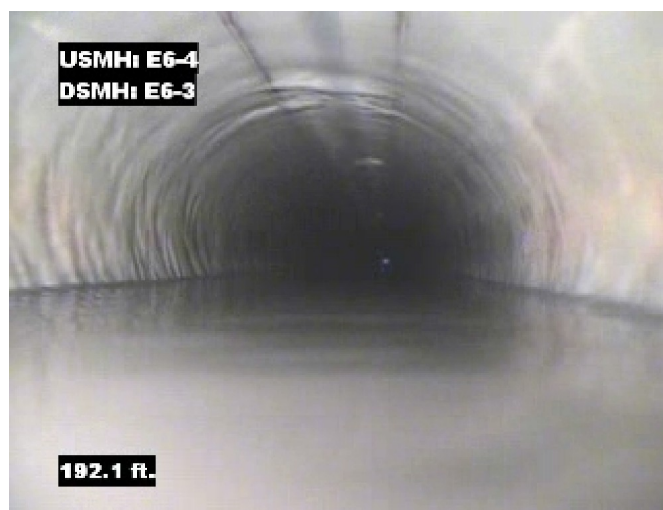
Distance: 192.2 ft. Grade: 3
Condition: Lining Failure Wrinkled
Remarks: N/A

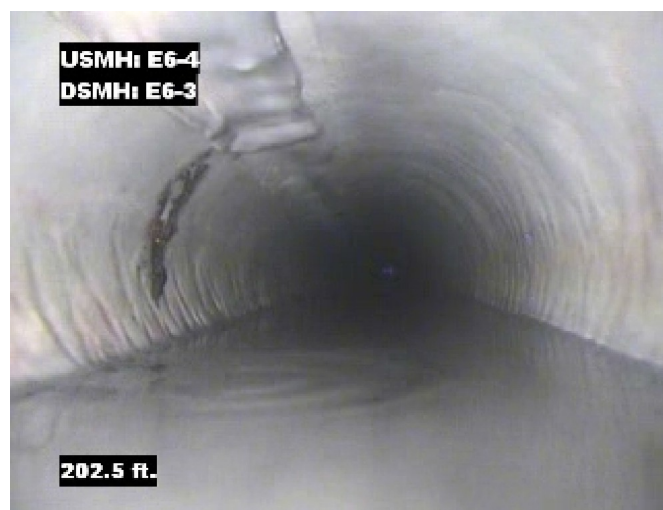
Distance: 202.5 ft. Grade: 3
Condition: Lining Failure Delaminating
Remarks: N/A

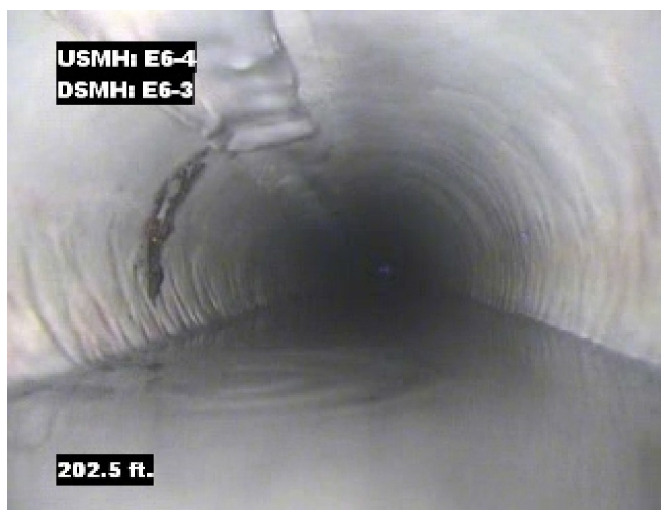
Distance: 203.0 ft. Grade: 0
Condition: Infiltration Stain
Remarks: N/A

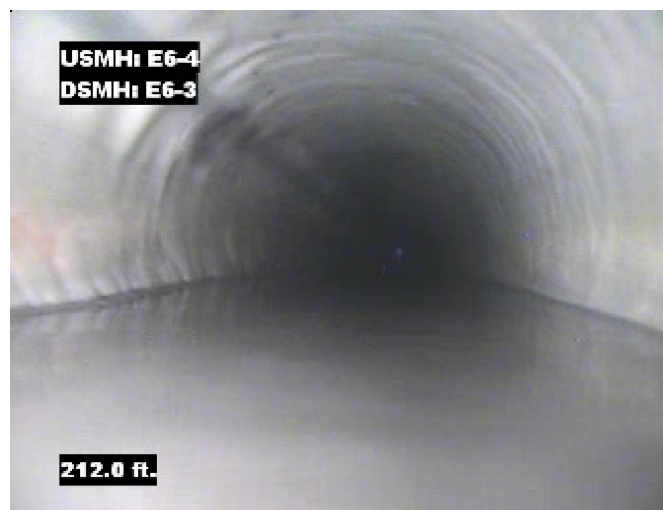
Distance: 212.3 ft. Grade: 3
Condition: Lining Failure Wrinkled
Remarks: N/A

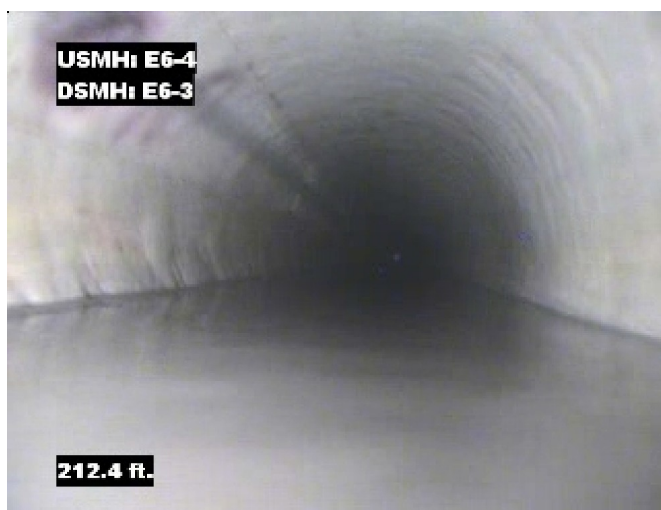
Distance: 212.7 ft. Grade: 0
Condition: Infiltration Stain
Remarks: N/A

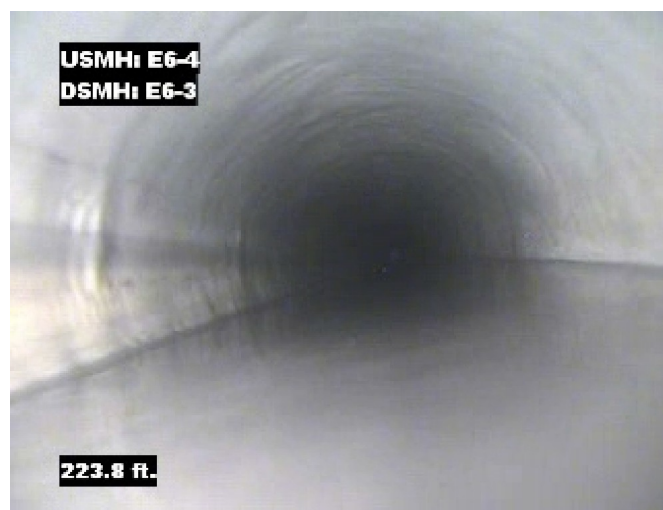
Distance: 223.9 ft. Grade: 3
Condition: Lining Failure Wrinkled
Remarks: N/A

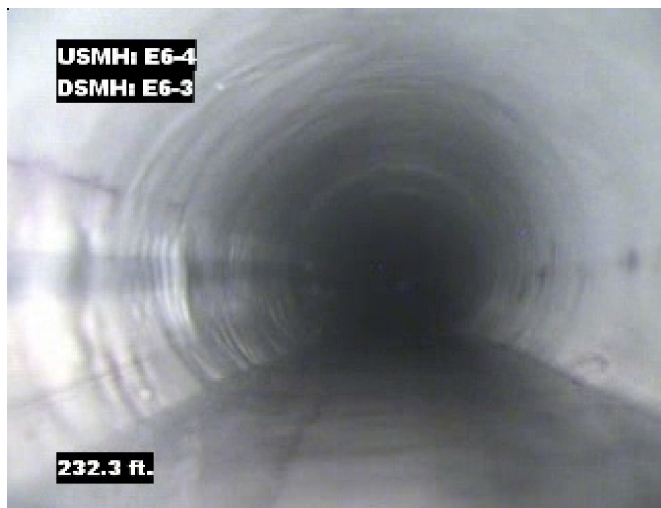
Distance: 232.3 ft. Grade: 3
Condition: Lining Failure Wrinkled
Remarks: N/A

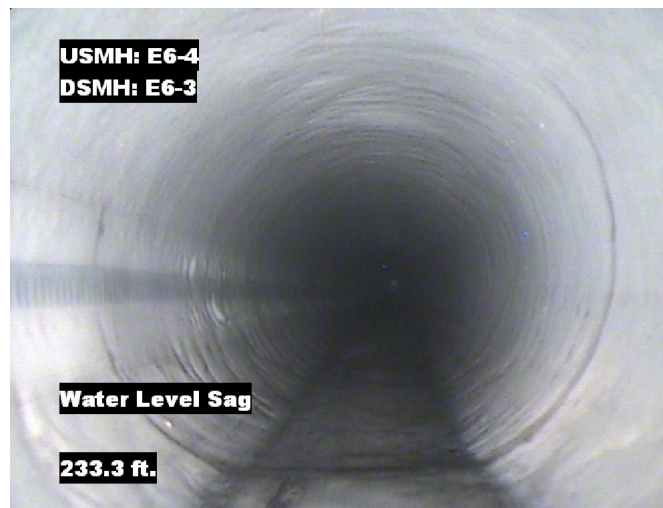
Distance: 233.3 ft. Grade: 2
Condition: Water Level Sag
Remarks: N/A

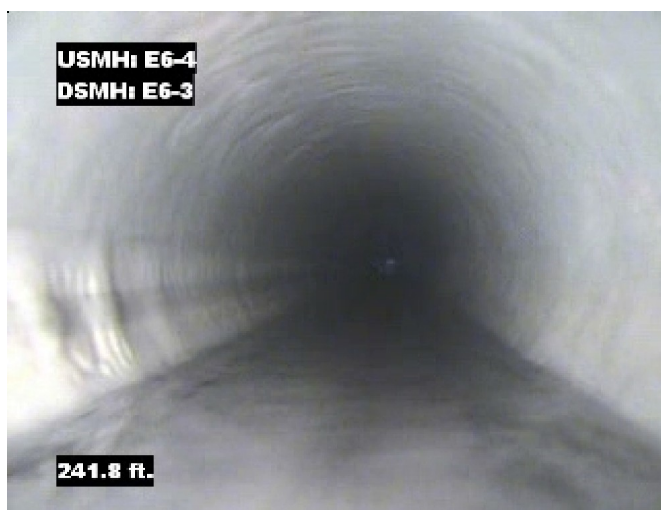
Distance: 241.9 ft. Grade: 3
Condition: Lining Failure Wrinkled
Remarks: N/A

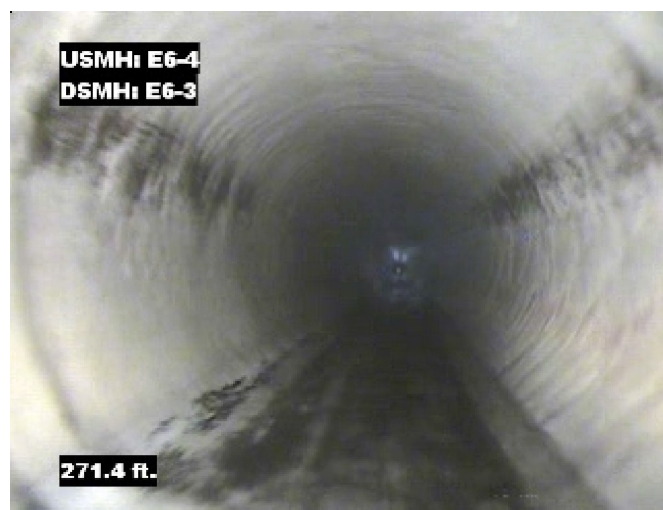
Distance: 271.4 ft. Grade: 3
Condition: Lining Failure Wrinkled
Remarks: N/A

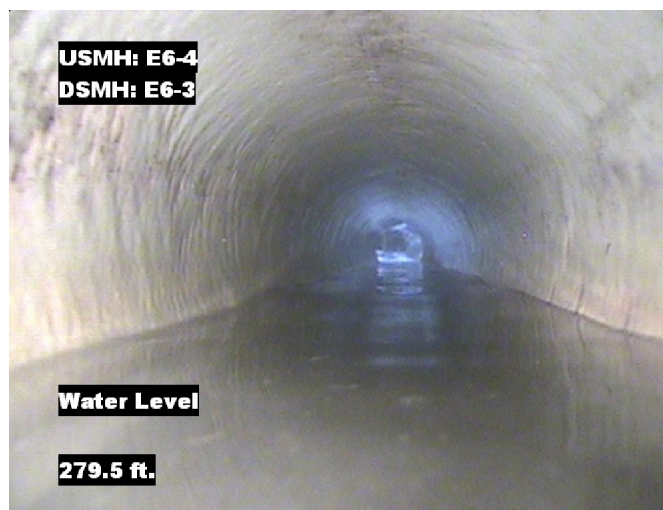
Distance: 279.5 ft. Grade: 0
Condition: Water Level
Remarks: N/A

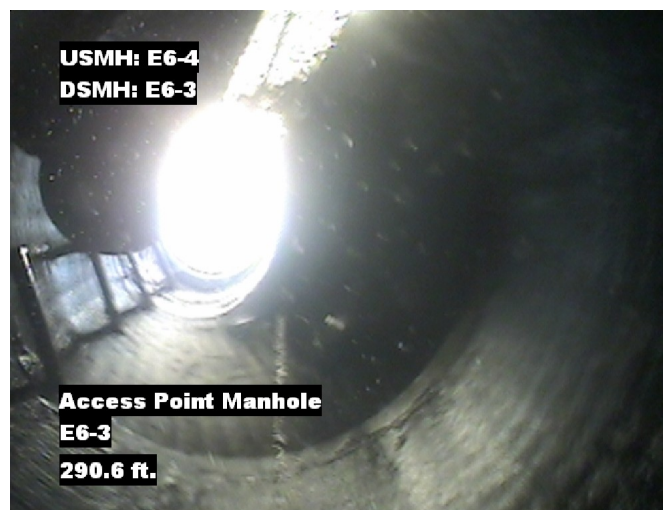
Distance: 290.6 ft. Grade: 0
Condition: Access Point Manhole
Remarks: E6-3
