## Defect Listing

Pipe Segment Refere... <b>E6-5_E6-4</b>	City <b>Oliver Springs</b>	Street <b>Hwy61&amp;62</b>	Material <b>PolyVinyl Chloride</b>	Location C... <b>Main Highw...</b>	Sewer Use <b>Sanitary</b>
Upstream MH <b>E6-5</b>	Total Length <b>120.4</b>	Year Laid	Shape <b>Circular</b>	Location Details <b>Runs under Hwy</b>	
DS Manhole <b>E6-4</b>	Length surveyed <b>120.4</b>	Year Renewed	Height <b>8</b>	Width <b>8</b>	Pipe Joint... <b>13</b>

SPR <b>12</b>	MPR <b>6</b>	PO Number <b>4397-03</b>	Customer <b>GRW</b>
SPRI <b>3</b>	MPRI <b>2</b>	Work Order <b>4397-02</b>	Purpose <b>Pre-Rehabilitation Survey</b>
QSR <b>3400</b>	QMR <b>2300</b>		
OPR <b>18</b>	Surveyed By <b>Barry Rogers</b>	Direction <b>Downstream</b>	Date <b>20150616</b>
OPRI <b>2.6</b>	Certificate Number <b>U-1012-16405</b>	Pre-Cleaning <b>Jetting</b>	Time <b>08:57</b>
	Date Cleaned <b>20150616</b>	End Time <b>09:03</b>	Weather <b>Very Dry</b>
			Media label
			Additional Info

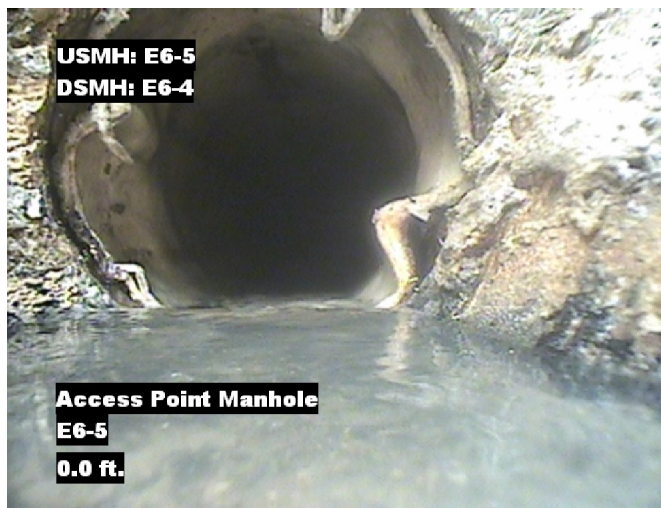
Distance: 0.0 ft. Grade: 0  
Condition: Access Point Manhole  
Remarks: E6-5

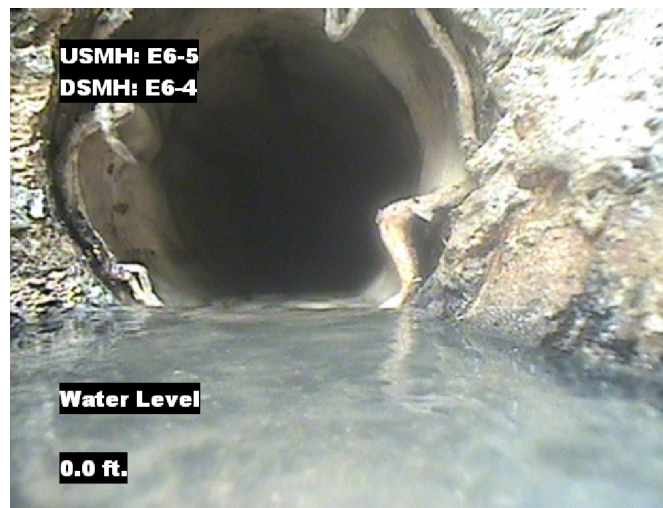
Distance: 0.0 ft. Grade: 0  
Condition: Water Level  
Remarks: N/A

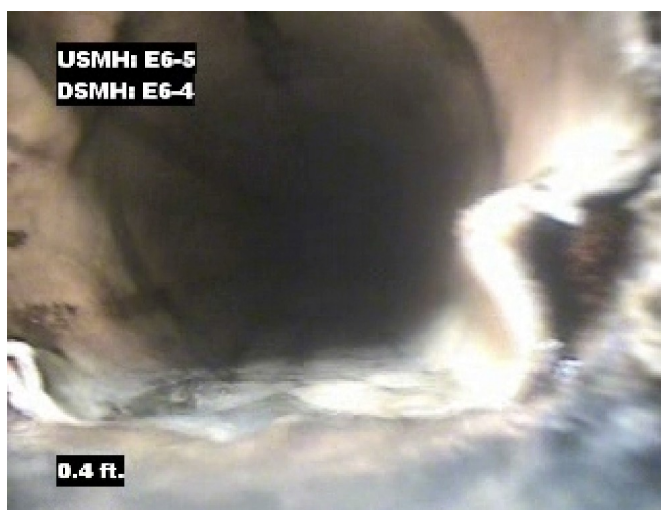
Distance: 0.4 ft. Grade: 3  
Condition: Lining Failure Defective End  
Remarks: N/A

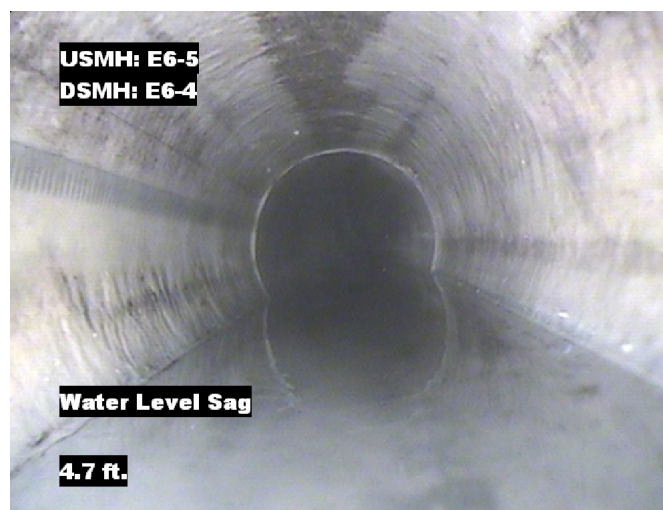
Distance: 4.7 ft. Grade: 2  
Condition: Water Level Sag  
Remarks: N/A

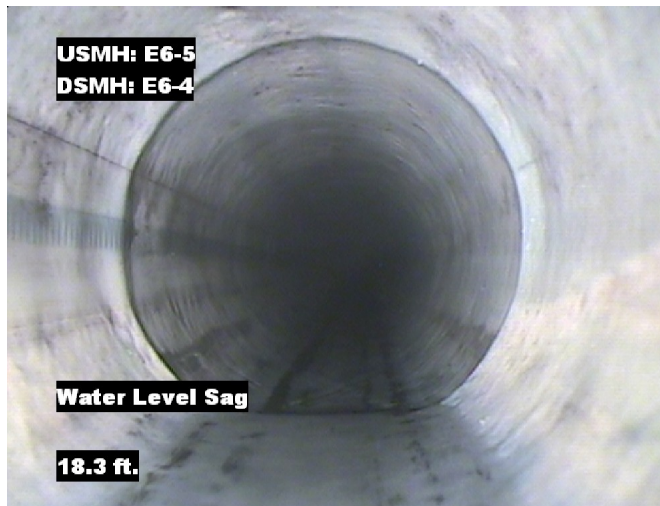
Distance: 18.3 ft. Grade: 2  
Condition: Water Level Sag  
Remarks: N/A

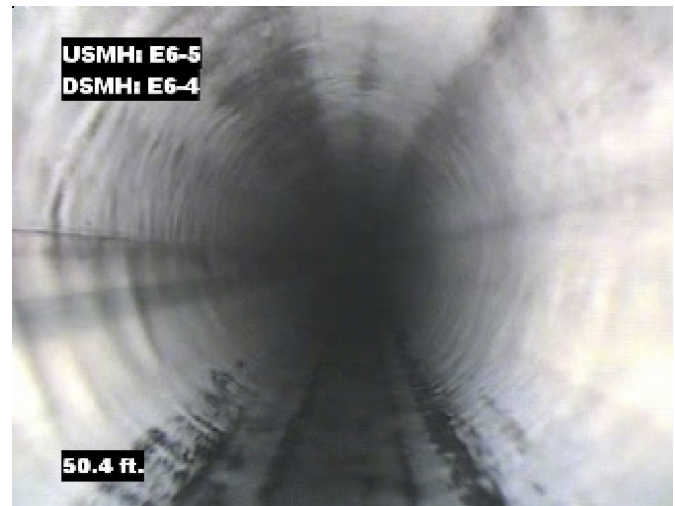
Distance: 50.5 ft. Grade: 3  
Condition: Lining Failure Wrinkled  
Remarks: N/A

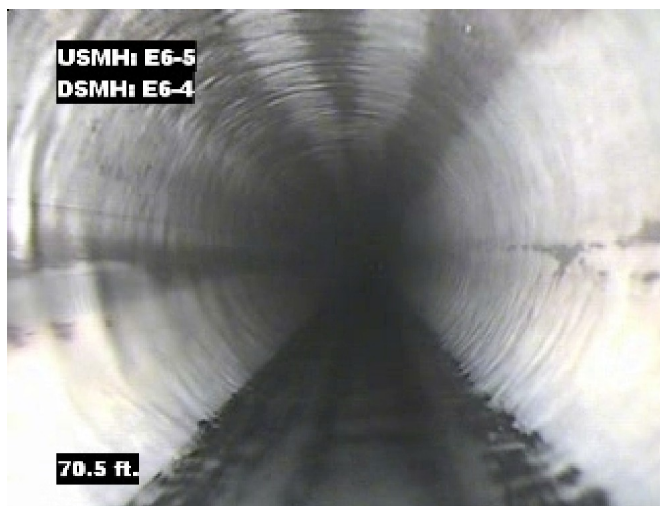
Distance: 70.5 ft. Grade: 3  
Condition: Lining Failure Wrinkled  
Remarks: N/A

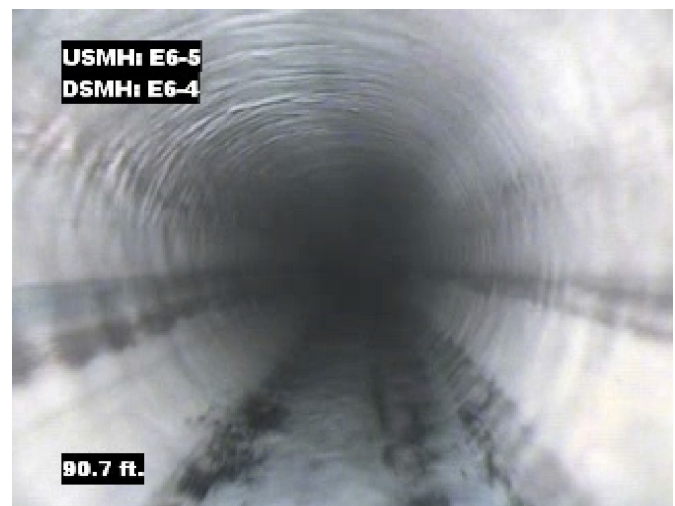
Distance: 90.7 ft. Grade: 3  
Condition: Lining Failure Wrinkled  
Remarks: N/A

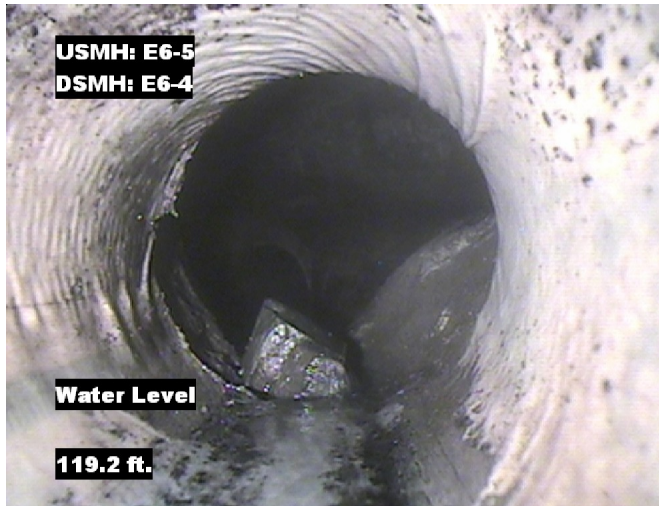
Distance: 119.2 ft. Grade: 0  
Condition: Water Level  
Remarks: N/A

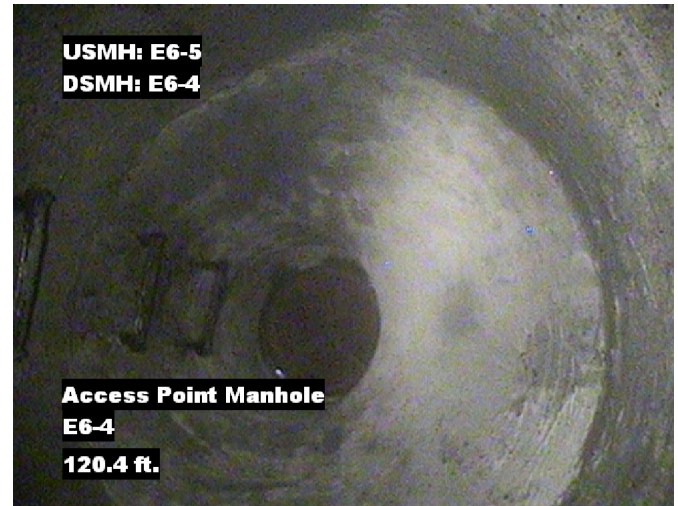
Distance: 120.4 ft. Grade: 0  
Condition: Access Point Manhole  
Remarks: E6-4
