Defect Listing

Pipe Segment Refere... E6-6_E6-5	City Oliver Springs	Street Hwy61	Material PolyVinyl Chloride	Location C... Parking Lo...	Sewer Use Sanitary
Upstream MH E6-6	Total Length 49.6	Year Laid	Shape Circular	Location Details Car Wash PArking Lo...	
DS Manhole E6-5	Length surveyed 49.6	Year Renewed	Height 8	Width 8	Pipe Joint... 13

Image Report 4/Page

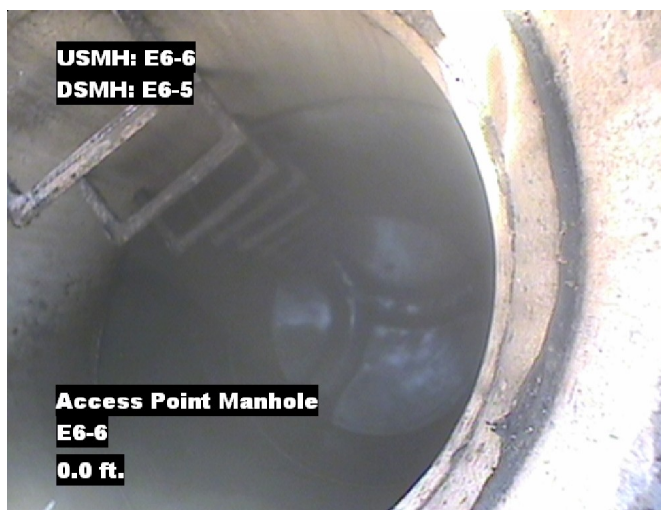
Distance: 0.0 ft. Grade: 0
Condition: Access Point Manhole
Remarks: E6-6

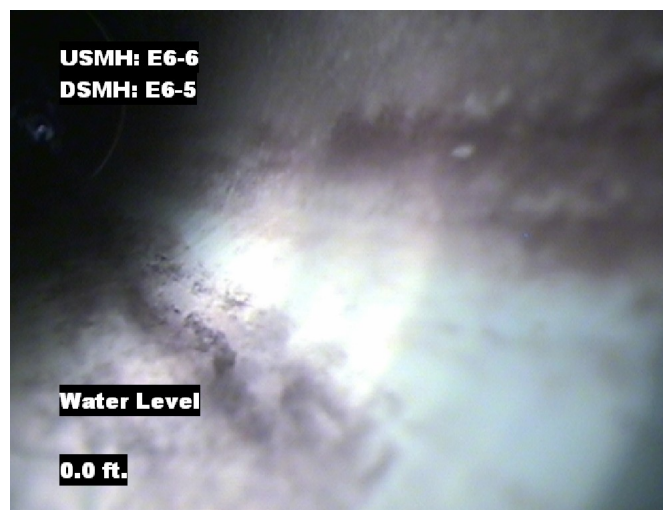
Distance: 0.0 ft. Grade: 0
Condition: Water Level
Remarks: N/A

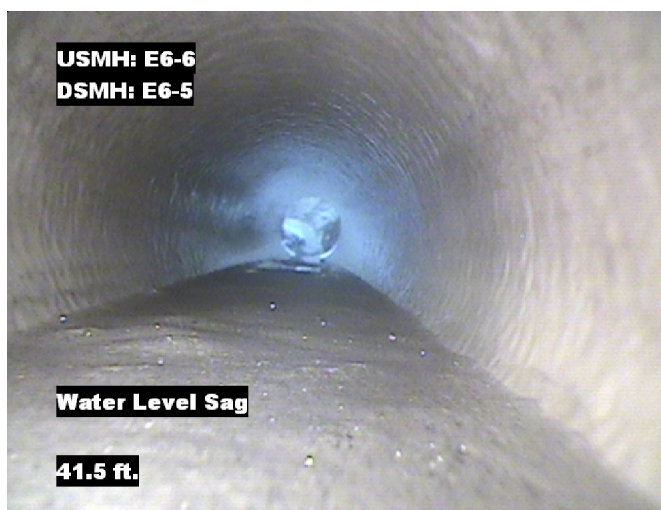
Distance: 41.5 ft. Grade: 2
Condition: Water Level Sag
Remarks: N/A

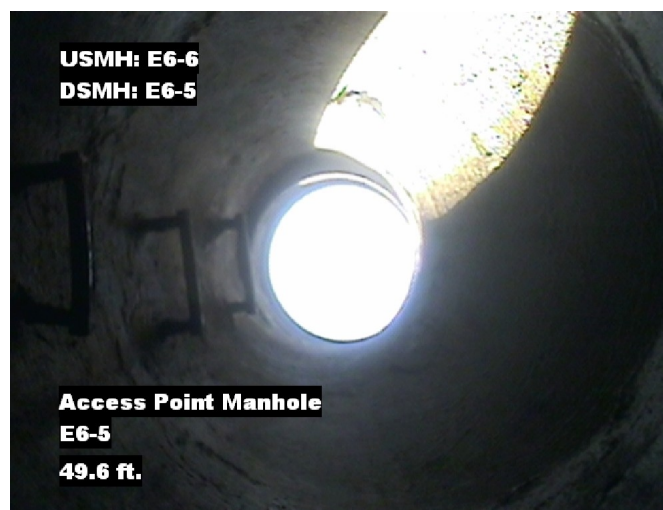
Distance: 49.6 ft. Grade: 0
Condition: Access Point Manhole
Remarks: E6-5
