## Defect Listing

Pipe Segment Refere... <b>E6-6A_E6-6</b>	City <b>Oliver Springs</b>	Street <b>Parking Lot</b>	Material <b>PolyVinyl Chloride</b>	Location C... <b>Parking Lo...</b>	Sewer Use <b>Sanitary</b>
Upstream MH <b>E6-6A</b>	Total Length <b>161.6</b>	Year Laid	Shape <b>Circular</b>	Location Details <b>Off HWY 62</b>	
DS Manhole <b>E6-6</b>	Length surveyed <b>161.6</b>	Year Renewed	Height <b>8</b>	Width <b>8</b>	Pipe Joint... <b>13</b>

SPR <b>N/A</b>	MPR <b>N/A</b>	PO Number <b>4397-03</b>		Customer <b>GRW</b>	
SPRI <b>N/A</b>	MPRI <b>N/A</b>	Work Order <b>4397-02</b>		Purpose <b>Pre-Rehabilitation Survey</b>	
QSR <b>N/A</b>	QMR <b>N/A</b>				
OPR <b>N/A</b>	Surveyed By <b>Barry Rogers</b>	Direction <b>Downstream</b>	Date <b>20150615</b>	Media label	
OPRI <b>N/A</b>	Certificate Number <b>U-1012-16405</b>	Pre-Cleaning <b>Jetting</b>	Time <b>11:03</b>	Weather <b>Very Dry</b>	
Date Cleaned <b>20150615</b>			End Time <b>11:11</b>	Additional Info

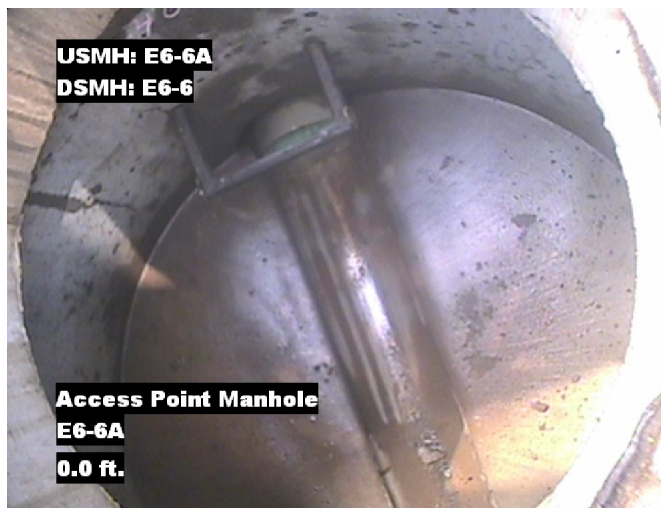
Distance: 0.0 ft. Grade: 0  
Condition: Access Point Manhole  
Remarks: E6-6A

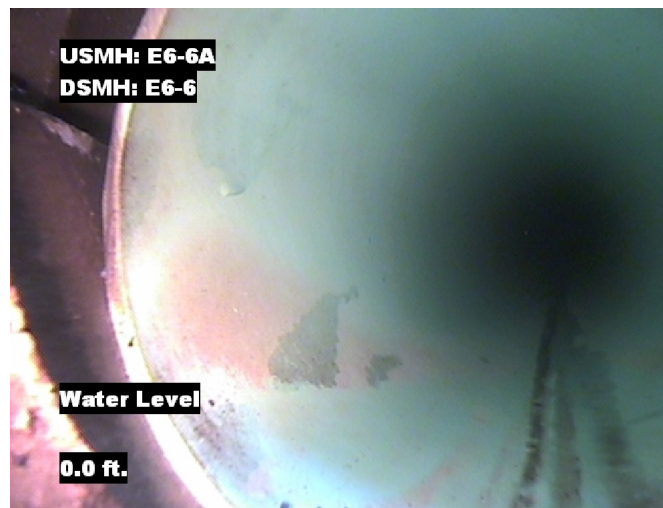
Distance: 0.0 ft. Grade: 0  
Condition: Water Level  
Remarks: N/A

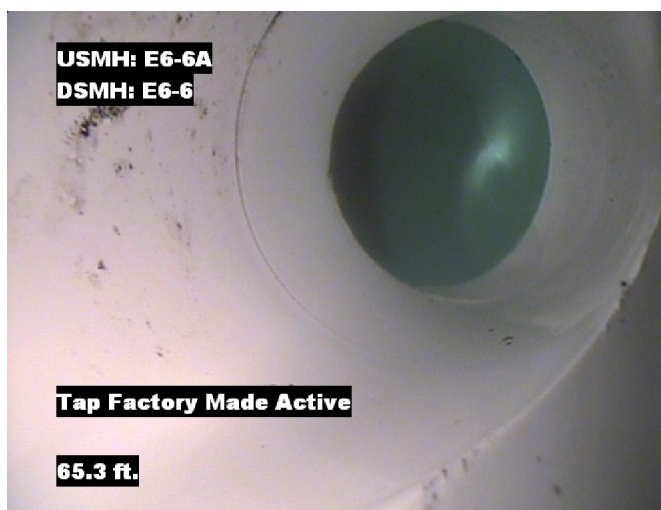
Distance: 65.3 ft. Grade: 0  
Condition: Tap Factory Made Active  
Remarks: N/A

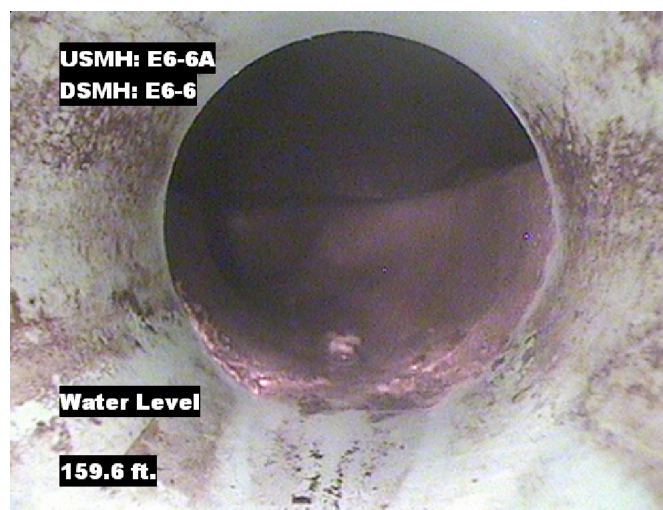
Distance: 159.6 ft. Grade: 0  
Condition: Water Level  
Remarks: N/A

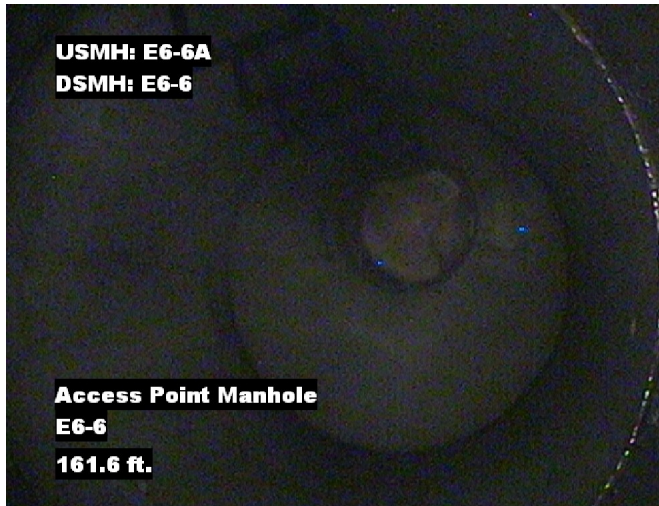
Distance: 161.6 ft. Grade: 0  
Condition: Access Point Manhole  
Remarks: E6-6
