Defect Listing

| Pipe Segment Refere... E6-7_E6-6 | City Oliver Springs | Street Parking Lot | Material PolyVinyl Chloride | Location C... Parking Lo... | Sewer Use Sanitary |

| SPRI N/A | MPRI N/A | Work Order 4397-02 | | Purpose Pre-Rehabilitation Survey | |

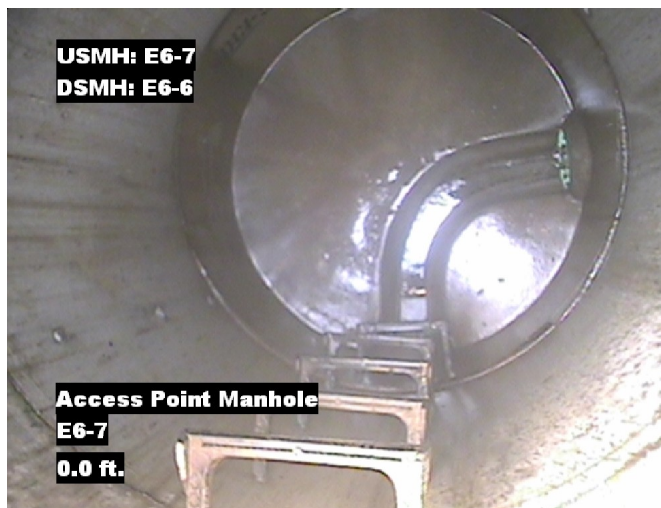
Distance: 0.0 ft. Grade: 0
Condition: Access Point Manhole
Remarks: E6-7

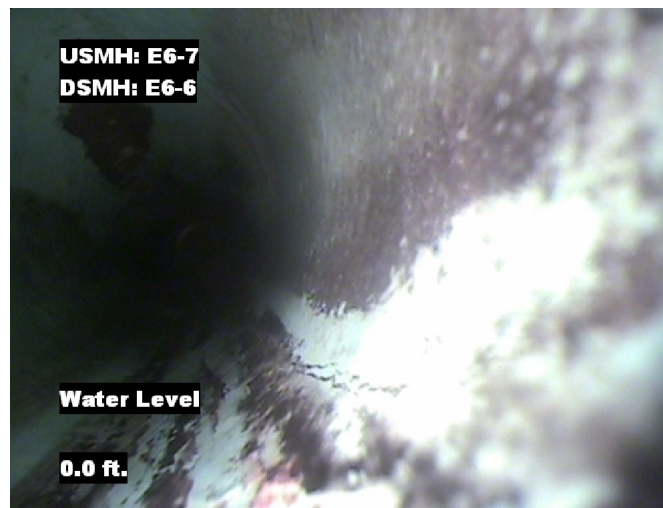
Distance: 0.0 ft. Grade: 0
Condition: Water Level
Remarks: N/A

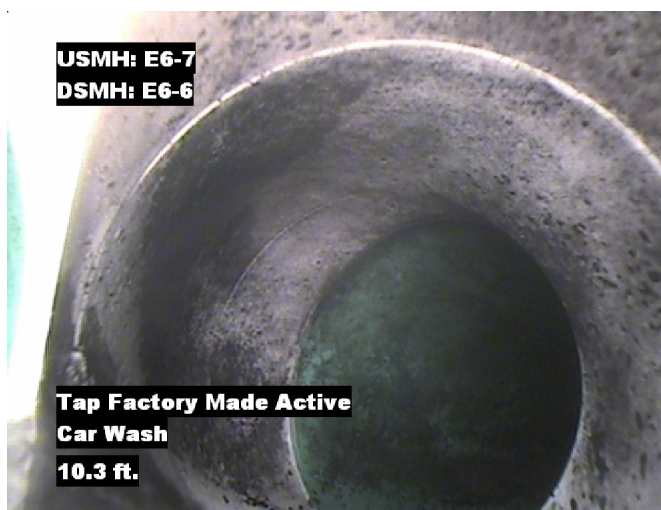
| Distance | Condition | Cont. Dfct. | Values | | | Joint | Clock Position | | Grade |
|---|---|---|---|---|---|---|---|---|---|
| 10.3 ft. | Tap Factory Made Active | | 8 | | 0 | <input checked="" type="checkbox"/> | 12 | | |
| Remarks: Car Wash | | | | | | | | | |

Distance: 10.3 ft. Grade: 0
Condition: Tap Factory Made Active
Remarks: Car Wash

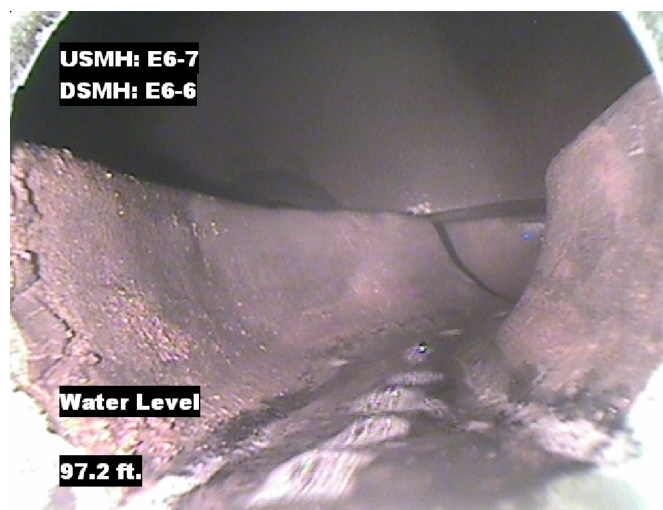
Distance: 97.2 ft. Grade: 0
Condition: Water Level
Remarks: N/A

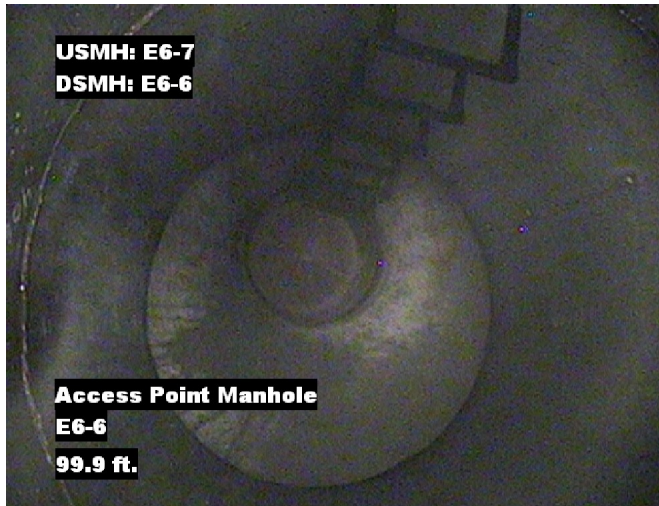
Distance: 99.9 ft. Grade: 0
Condition: Access Point Manhole
Remarks: E6-6
