Defect Listing

Pipe Segment Refere... E6-8_E6-7	City Oliver Springs	Street Parking LOt	Material PolyVinyl Chloride	Location C... Parking Lo...	Sewer Use Sanitary
Upstream MH E6-8	Total Length 101.7	Year Laid	Shape Circular	Location Details Off HWY 62	
DS Manhole E6-7	Length surveyed 101.7	Year Renewed	Height 8	Width 8	Pipe Joint... 13

Image Report 4/Page

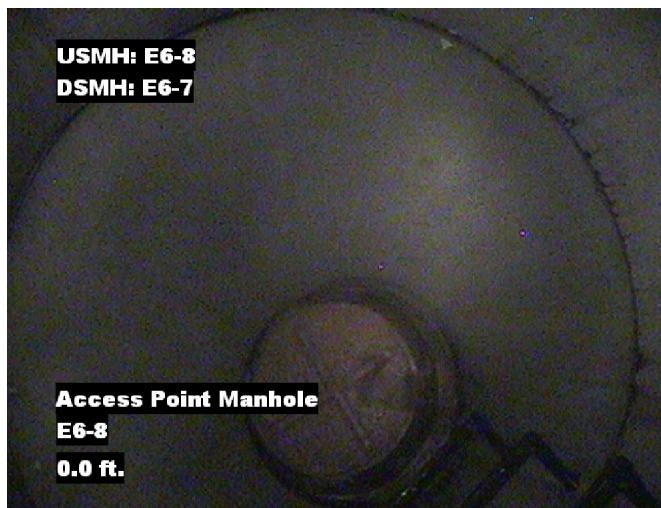
Distance: 0.0 ft. Grade: 0
Condition: Access Point Manhole
Remarks: E6-8

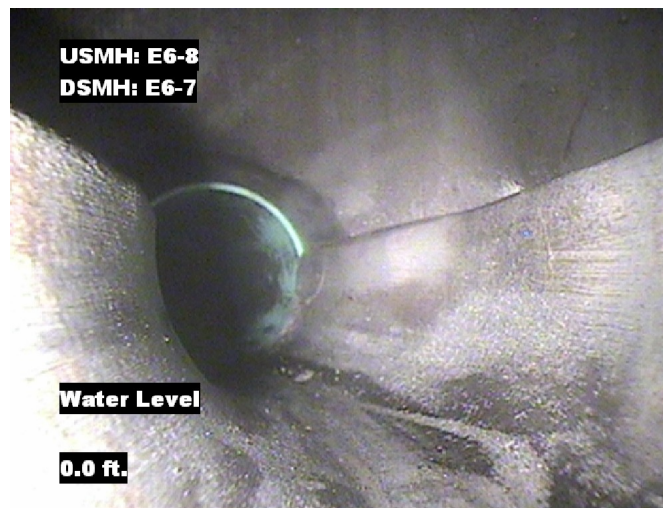
Distance: 0.0 ft. Grade: 0
Condition: Water Level
Remarks: N/A

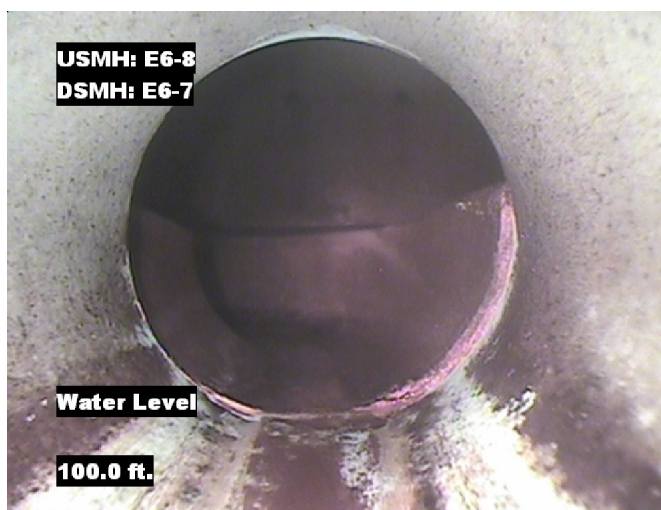
Distance: 100.0 ft. Grade: 0
Condition: Water Level
Remarks: N/A

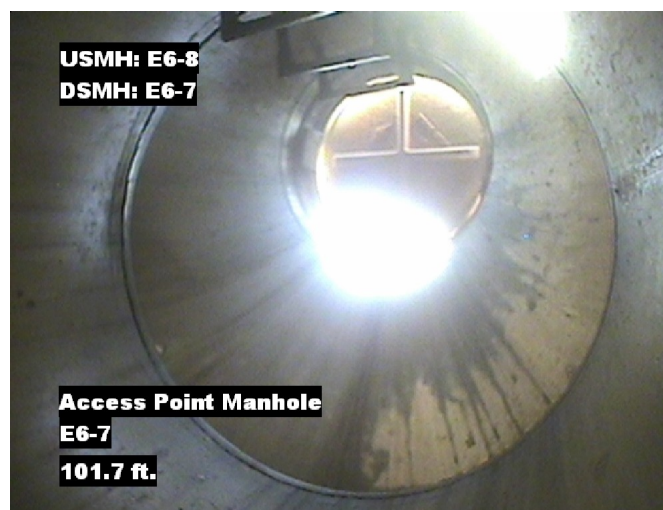
Distance: 101.7 ft. Grade: 0
Condition: Access Point Manhole
Remarks: E6-7
