Defect Listing

Pipe Segment Refere... E6-9_E6-8	City Oliver Springs	Street Parking Lot	Material PolyVinyl Chloride	Location C... Parking Lo...	Sewer Use Sanitary
Upstream MH E6-9	Total Length 75.6	Year Laid	Shape Circular	Location Details Church Parking LOt	
DS Manhole E6-8	Length surveyed 75.6	Year Renewed	Height 8	Width 8	Pipe Joint... 13

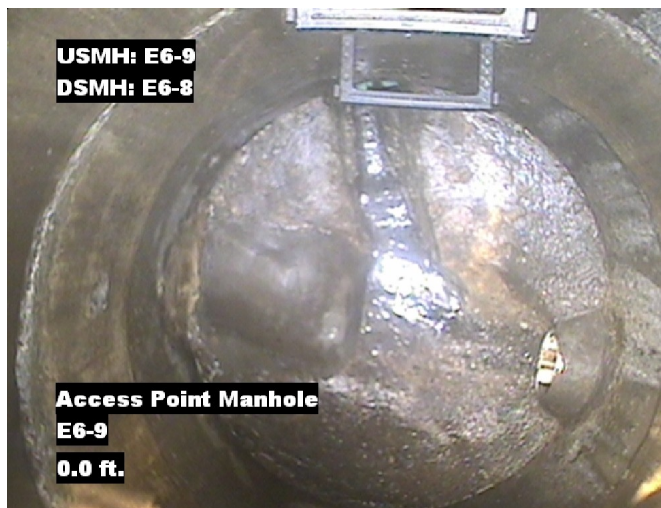
Distance: 0.0 ft. Grade: 0
Condition: Access Point Manhole
Remarks: E6-9

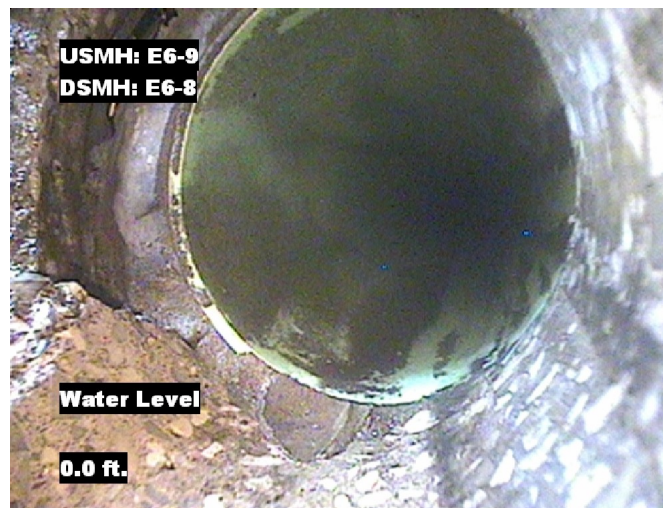
Distance: 0.0 ft. Grade: 0
Condition: Water Level
Remarks: N/A

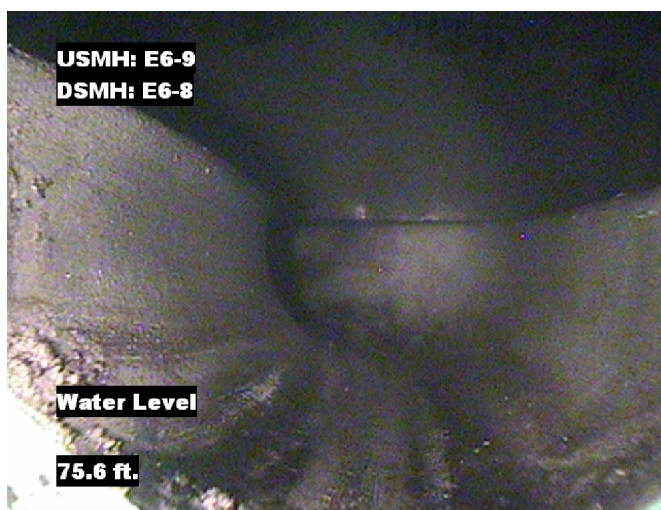
Distance: 75.6 ft. Grade: 0
Condition: Water Level
Remarks: N/A

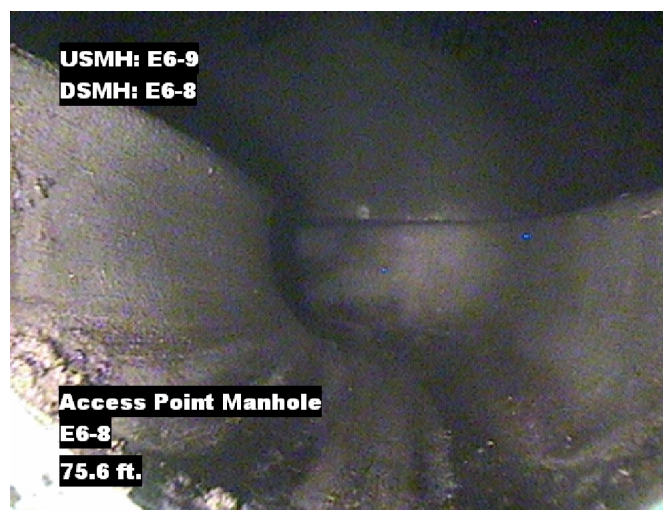
Distance: 75.6 ft. Grade: 0
Condition: Access Point Manhole
Remarks: E6-8
