Defect Listing

Pipe Segment Refere... E6-9A_E6-9	City Oliver Springs	Street Easement	Material PolyVinyl Chloride	Location C... Parking Lo...	Sewer Use Sanitary
Upstream MH E6-9A	Total Length 204.6	Year Laid	Shape Circular	Location Details Church Parking Lot	
DS Manhole E6-9	Length surveyed 204.6	Year Renewed	Height 8	Width 8	Pipe Joint... 13

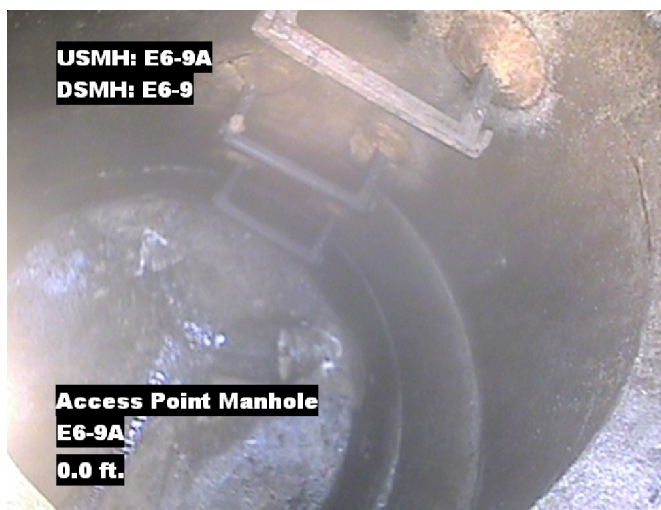
Distance: 0.0 ft. Grade: 0
Condition: Access Point Manhole
Remarks: E6-9A

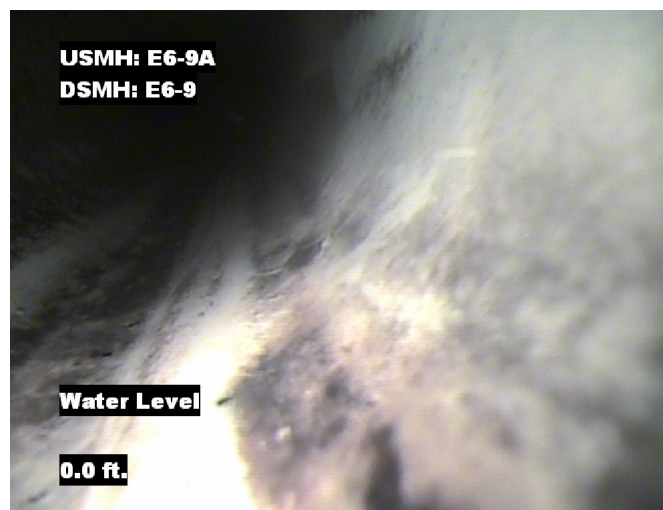
Distance: 0.0 ft. Grade: 0
Condition: Water Level
Remarks: N/A

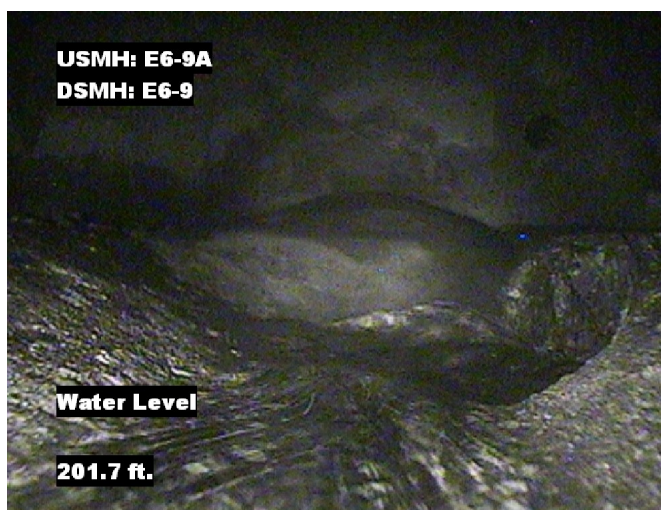
Distance: 201.7 ft. Grade: 0
Condition: Water Level
Remarks: N/A

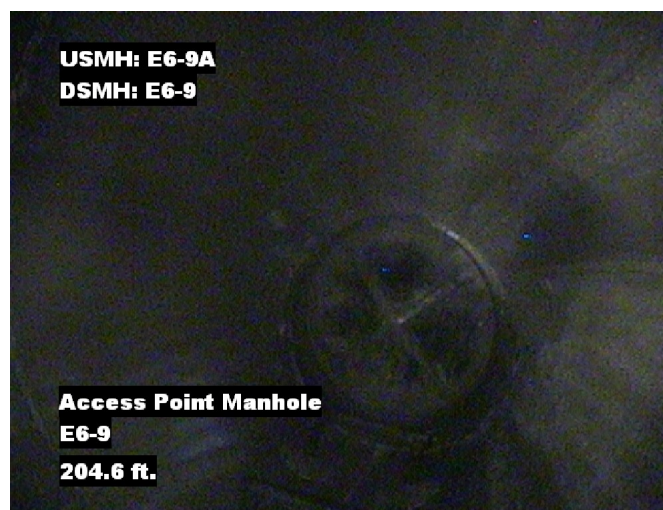
Distance: 204.6 ft. Grade: 0
Condition: Access Point Manhole
Remarks: E6-9
