Defect Listing

Pipe Segment Refere... E6-9B_E6-9A	City Oliver Springs	Street Easement	Material PolyVinyl Chloride	Location C... Parking Lo...	Sewer Use Sanitary
Upstream MH E6-9B	Total Length 326.2	Year Laid	Shape Circular	Location Details Church Parking lot	
DS Manhole E6-9A	Length surveyed 326.2	Year Renewed	Height 8	Width 8	Pipe Joint... 13

SPR N/A	MPR 5	PO Number 4397-03	Customer GRW
SPRI N/A	MPRI 2.5	Work Order 4397-02	Purpose Pre-Rehabilitation Survey
QSR N/A	QMR 3121		
OPR 5	Surveyed By Barry Rogers	Direction Downstream	Date 20150615
OPRI 2.5	Certificate Number U-1012-16405	Pre-Cleaning Jetting	Time 08:44
	Date Cleaned 20150615	End Time 09:06	Weather Very Dry
			Media label
			Additional Info

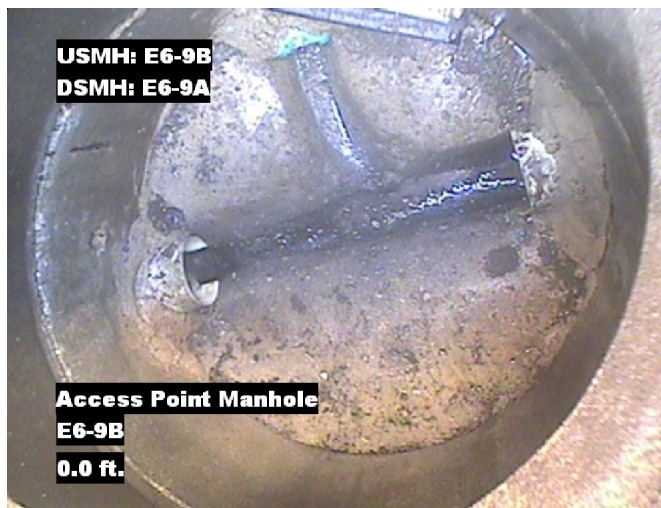
Distance: 0.0 ft. Grade: 0
Condition: Access Point Manhole
Remarks: E6-9B

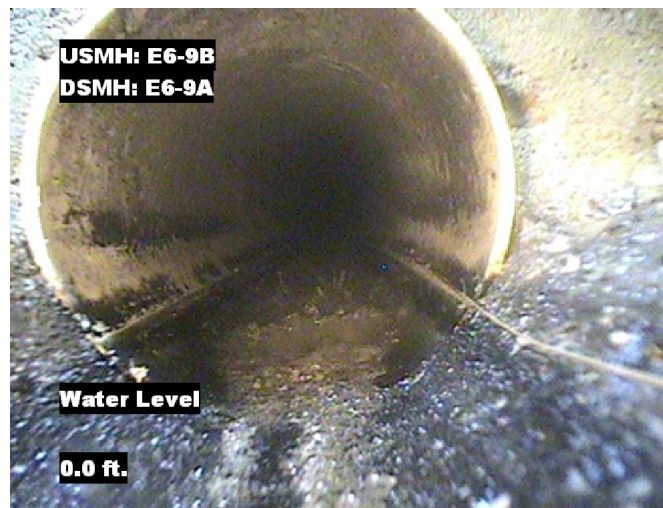
Distance: 0.0 ft. Grade: 0
Condition: Water Level
Remarks: N/A

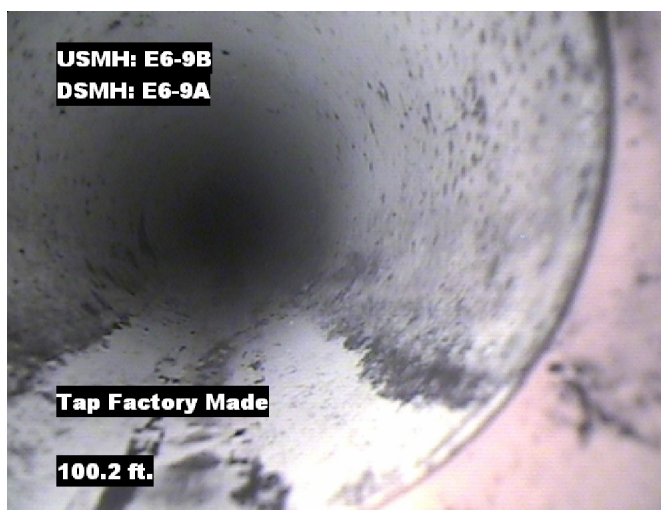
Distance: 100.2 ft. Grade: 0
Condition: Tap Factory Made
Remarks: N/A

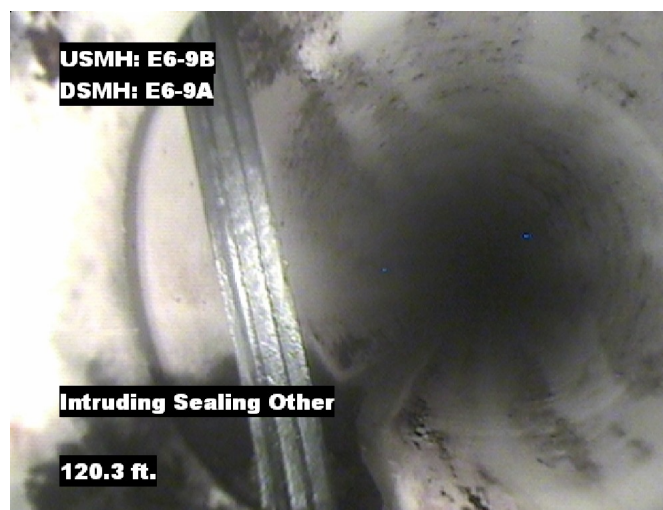
Distance: 120.3 ft. Grade: 3
Condition: Intruding Sealing Other
Remarks: N/A

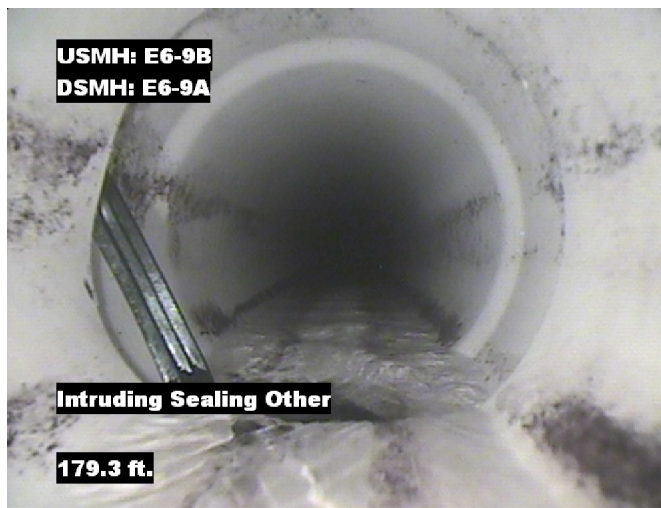
Distance: 179.3 ft. Grade: 2
Condition: Intruding Sealing Other
Remarks: N/A

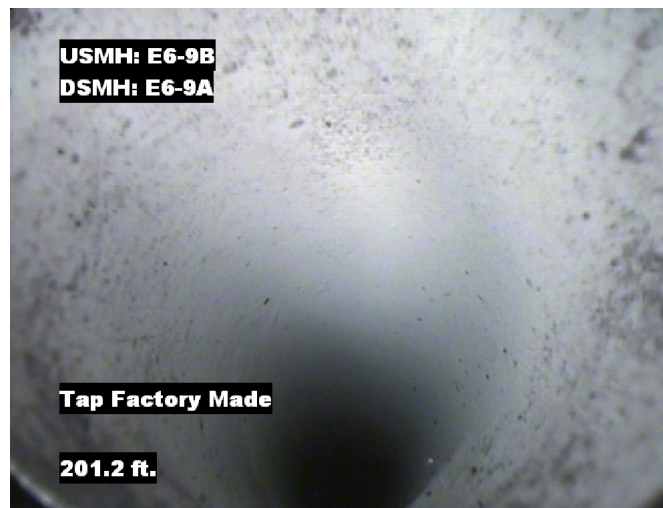
Distance: 201.2 ft. Grade: 0
Condition: Tap Factory Made
Remarks: N/A

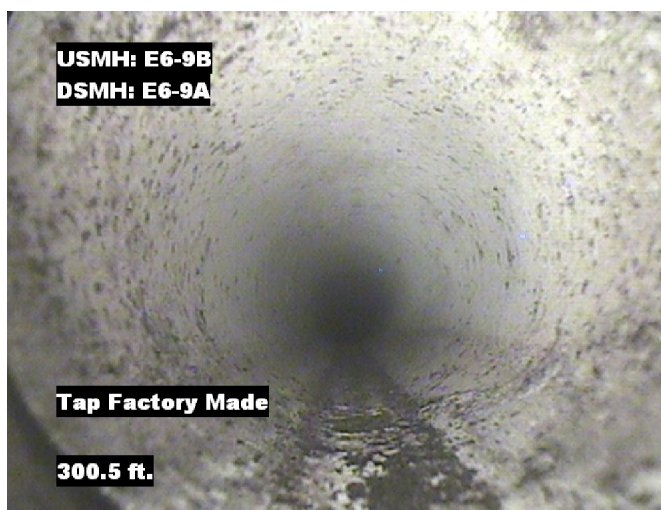
Distance: 300.5 ft. Grade: 0
Condition: Tap Factory Made
Remarks: N/A

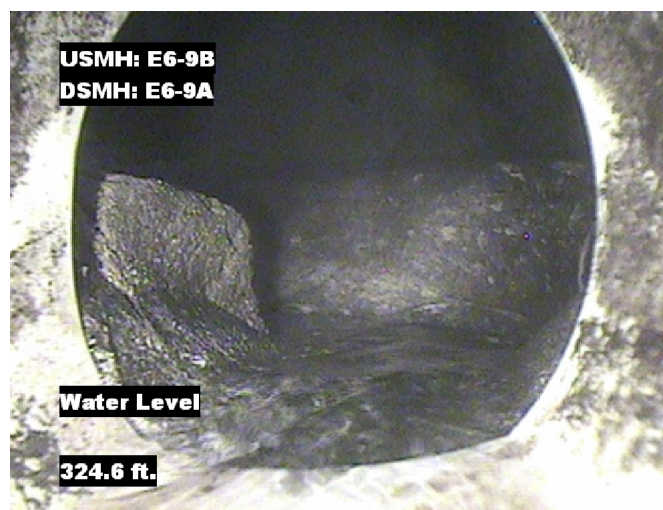
Distance: 324.6 ft. Grade: 0
Condition: Water Level
Remarks: N/A

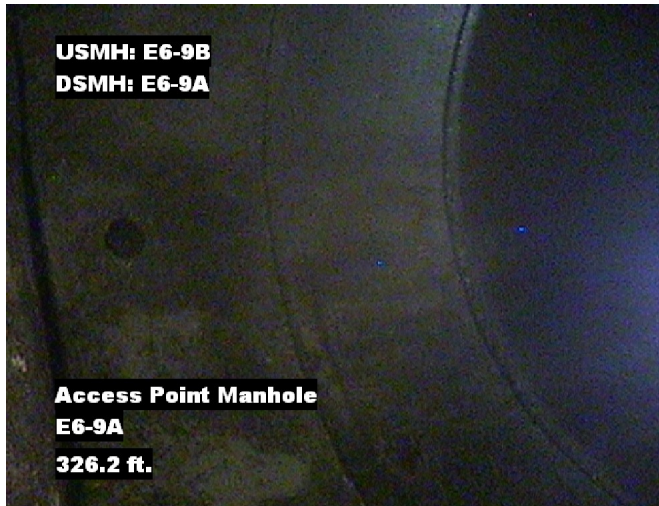
Distance: 326.2 ft. Grade: 0
Condition: Access Point Manhole
Remarks: E6-9A
