Defect Listing

Pipe Segment Refere... E6-9C_E6-9B	City Oliver Springs	Street Easement	Material PolyVinyl Chloride	Location C... Parking Lo...	Sewer Use Sanitary
Upstream MH E6-9C	Total Length 299.4	Year Laid	Shape Circular	Location Details Parking Lot in fron...	
DS Manhole E6-9B	Length surveyed 299.4	Year Renewed	Height 8	Width 8	Pipe Joint... 13

SPR N/A	MPR N/A	PO Number 4397-03	Customer GRW
SPRI N/A	MPRI N/A	Work Order 4397-02	Purpose Pre-Rehabilitation Survey
QSR N/A	QMR N/A		
OPR N/A	Surveyed By Barry Rogers	Direction Downstream	Date 20150615
OPRI N/A	Certificate Number U-1012-16405	Pre-Cleaning Jetting	Time 07:35
	Date Cleaned 20150615	End Time 08:26	Weather Very Dry
			Media label
			Additional Info

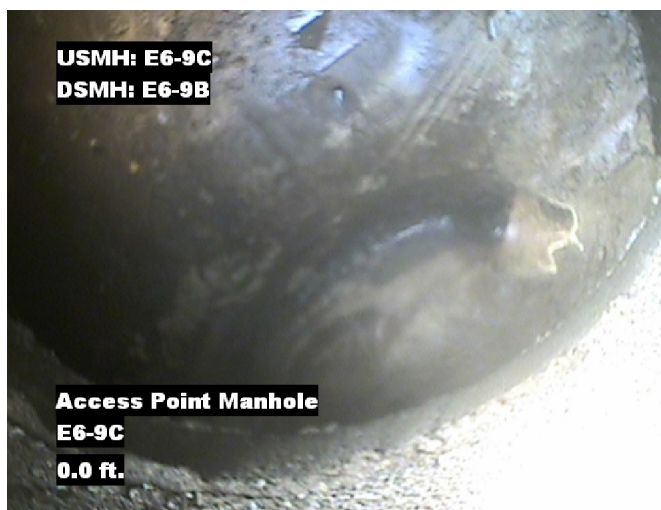
Distance: 0.0 ft. Grade: 0
Condition: Access Point Manhole
Remarks: E6-9C

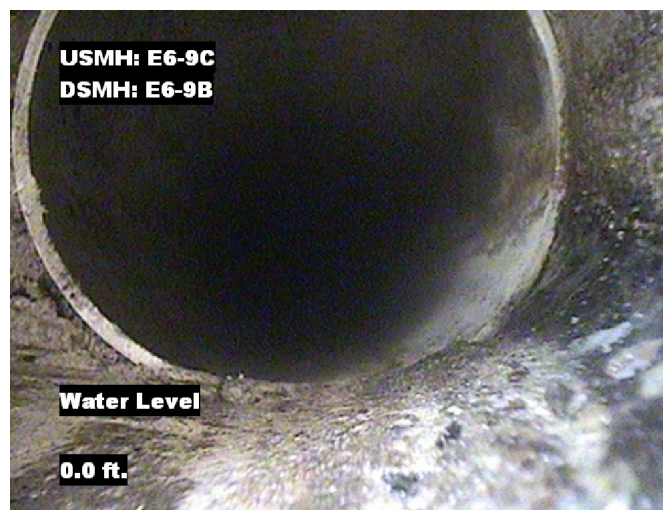
Distance: 0.0 ft. Grade: 0
Condition: Water Level
Remarks: N/A

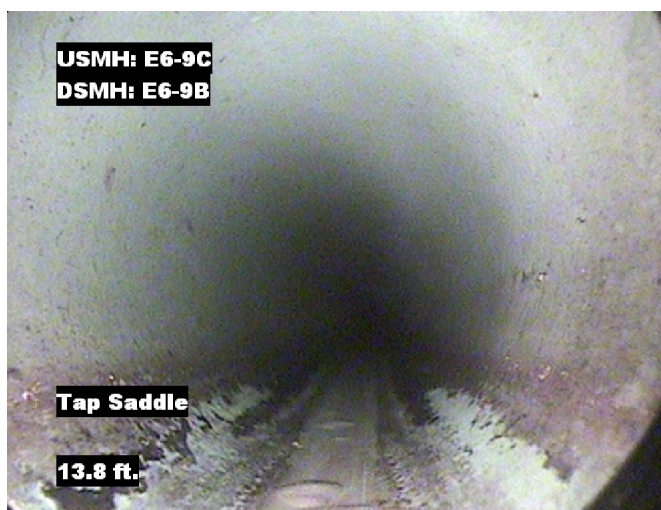
Distance: 13.8 ft. Grade: 0
Condition: Tap Saddle
Remarks: N/A

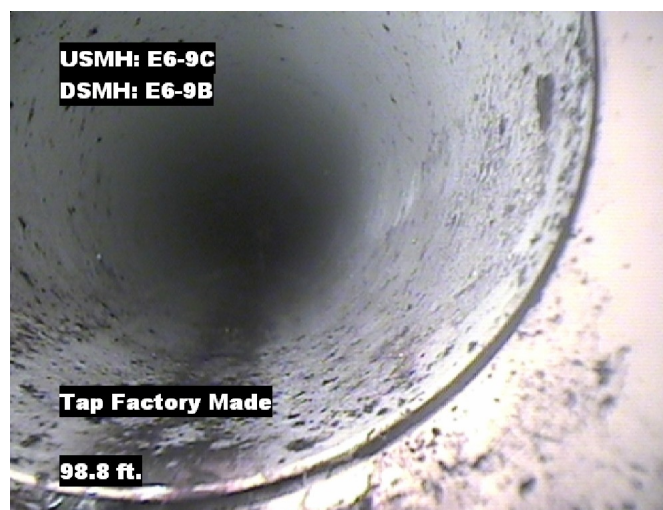
Distance: 98.8 ft. Grade: 0
Condition: Tap Factory Made
Remarks: N/A

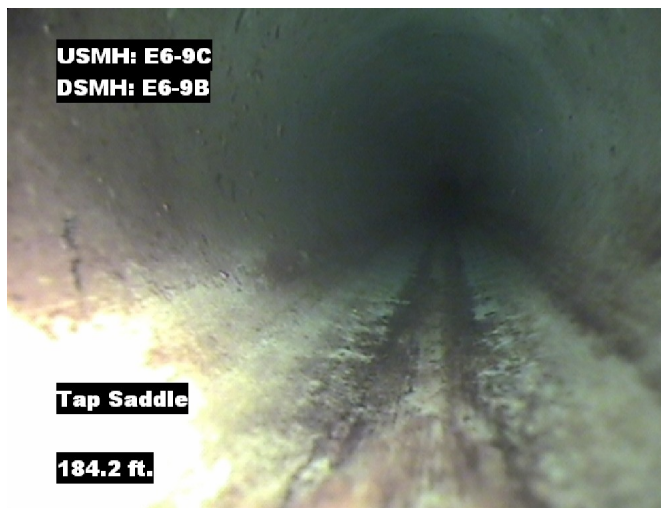
Distance: 184.2 ft. Grade: 0
Condition: Tap Saddle
Remarks: N/A

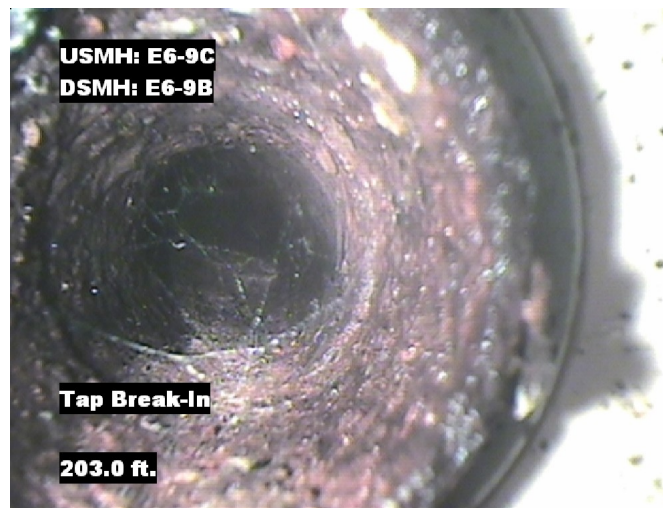
Distance: 203.0 ft. Grade: 0
Condition: Tap Break-In
Remarks: N/A

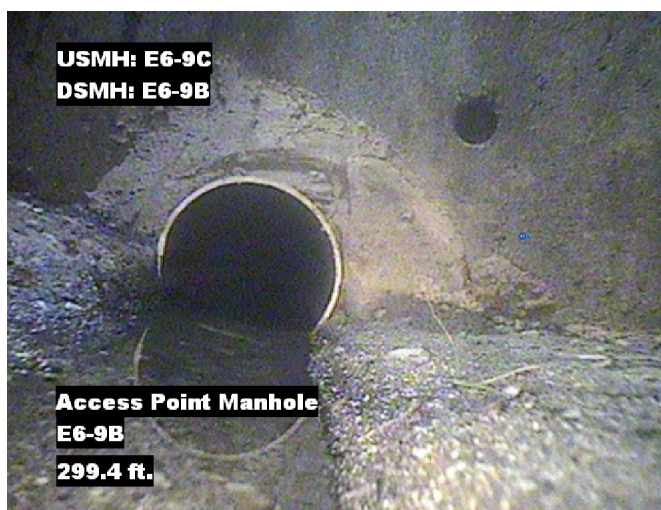
Distance: 299.4 ft. Grade: 0
Condition: Access Point Manhole
Remarks: E6-9B
