Defect Listing

Pipe Segment Refere... E7-3_E7-4	City Oliver Springs	Street Parking Lot	Material PolyVinyl Chloride	Location C... Parking Lo...	Sewer Use Sanitary
Upstream MH E7-3	Total Length 104.1	Year Laid	Shape Circular	Location Details Off Hwy 62	
DS Manhole E7-4	Length surveyed 104.1	Year Renewed	Height 8	Width 8	Pipe Joint... 13

SPR N/A	MPR N/A	PO Number 4397-03		Customer GRW	
SPRI N/A	MPRI N/A	Work Order 4397-02		Purpose Pre-Rehabilitation Survey	
QSR N/A	QMR N/A				
OPR N/A	Surveyed By Barry Rogers	Direction Downstream	Date 20150615	Media label	
OPRI N/A	Certificate Number U-1012-16405	Pre-Cleaning Jetting	Time 12:25	Weather Very Dry	
Date Cleaned 20150615			End Time 12:30	Additional Info

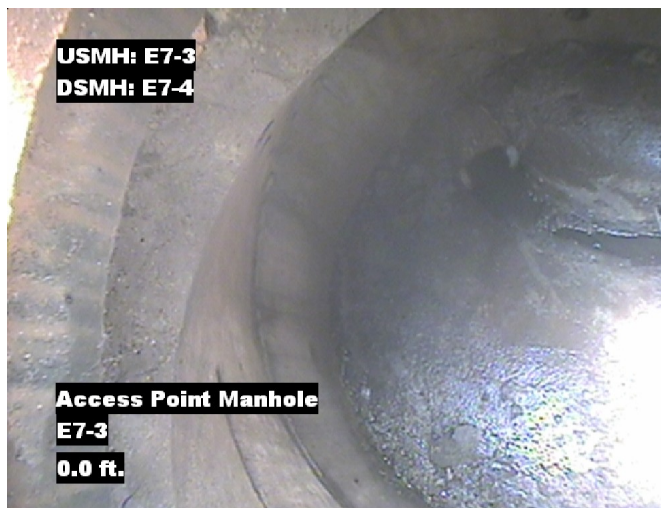
Distance: 0.0 ft. Grade: 0
Condition: Access Point Manhole
Remarks: E7-3

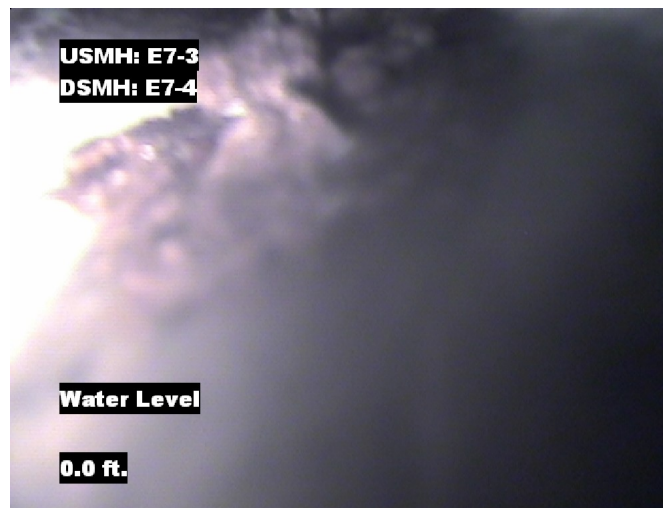
Distance: 0.0 ft. Grade: 0
Condition: Water Level
Remarks: N/A

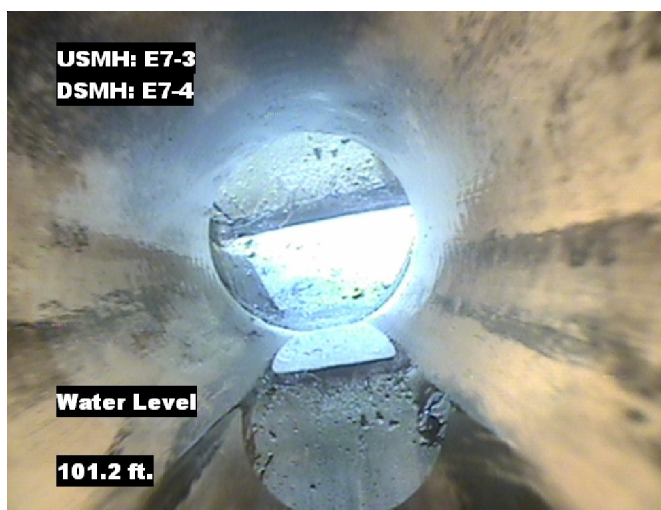
Distance: 101.1 ft. Grade: 0
Condition: Water Level
Remarks: N/A

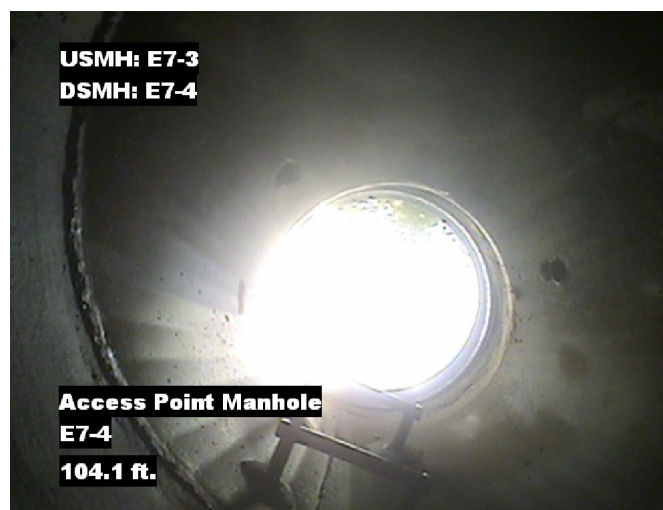
Distance: 104.1 ft. Grade: 0
Condition: Access Point Manhole
Remarks: E7-4
