Defect Listing

Pipe Segment Refere... E7-4_E7-5	City Oliver Springs	Street ParkingLot	Material PolyVinyl Chloride	Location C... Parking Lo...	Sewer Use Sanitary
Upstream MH E7-4	Total Length 141.2	Year Laid	Shape Circular	Location Details Off side of HWY 61	
DS Manhole E7-5	Length surveyed 141.2	Year Renewed	Height 8	Width 8	Pipe Joint... 13

Image Report 4/Page

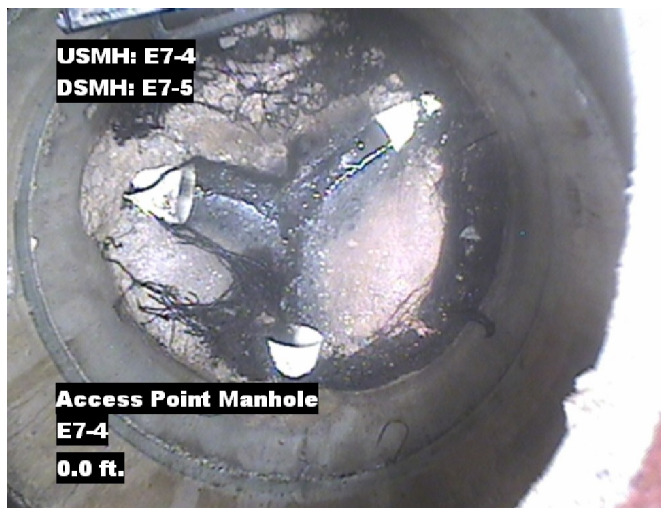
Distance: 0.0 ft. Grade: 0
Condition: Access Point Manhole
Remarks: E7-4

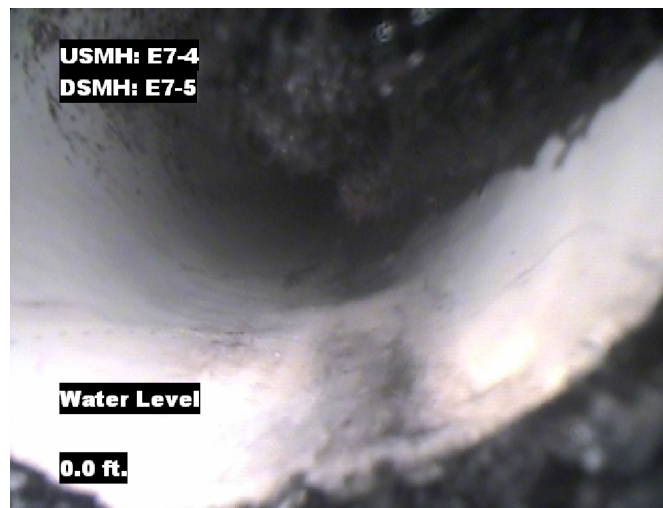
Distance: 0.0 ft. Grade: 0
Condition: Water Level
Remarks: N/A

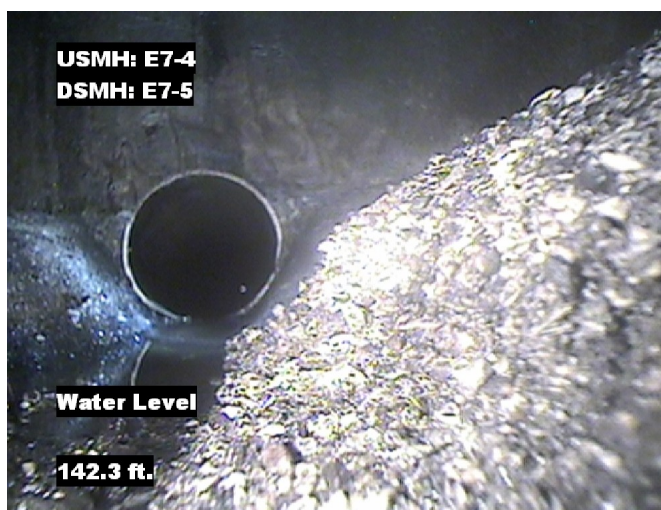
Distance: 141.0 ft. Grade: 0
Condition: Water Level
Remarks: N/A

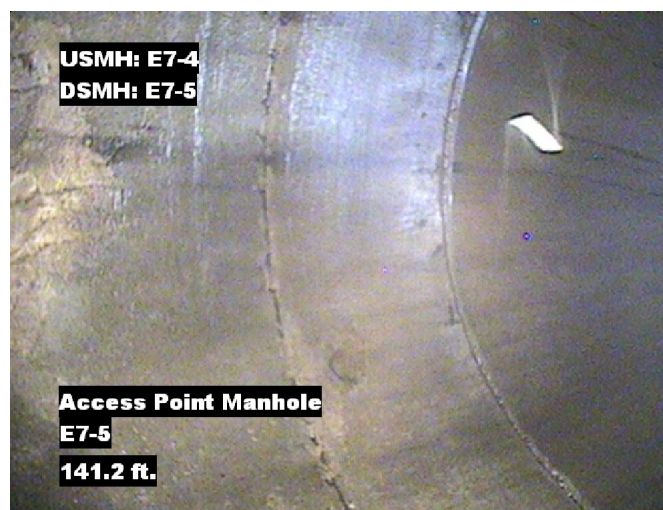
Distance: 141.2 ft. Grade: 0
Condition: Access Point Manhole
Remarks: E7-5
