## Defect Listing

Pipe Segment Refere... <b>E7-5_E7-6</b>	City <b>Oliver Springs</b>	Street <b>Parking Lot</b>	Material <b>PolyVinyl Chloride</b>	Location C... <b>Parking Lo...</b>	Sewer Use <b>Sanitary</b>
Upstream MH <b>E7-5</b>	Total Length <b>152.4</b>	Year Laid	Shape <b>Circular</b>	Location Details <b>Off Highway 61</b>	
DS Manhole <b>E7-6</b>	Length surveyed <b>152.4</b>	Year Renewed	Height <b>8</b>	Width <b>8</b>	Pipe Joint... <b>13</b>

SPR <b>N/A</b>	MPR <b>N/A</b>	PO Number <b>4397-03</b>		Customer <b>GRW</b>	
SPRI <b>N/A</b>	MPRI <b>N/A</b>	Work Order <b>4397-02</b>		Purpose <b>Pre-Rehabilitation Survey</b>	
QSR <b>N/A</b>	QMR <b>N/A</b>				
OPR <b>N/A</b>	Surveyed By <b>Barry Rogers</b>	Direction <b>Downstream</b>	Date <b>20150615</b>	Media label	
OPRI <b>N/A</b>	Certificate Number <b>U-1012-16405</b>	Pre-Cleaning <b>Jetting</b>	Time <b>13:24</b>	Weather <b>Very Dry</b>	
Date Cleaned <b>20150615</b>			End Time <b>13:34</b>	Additional Info

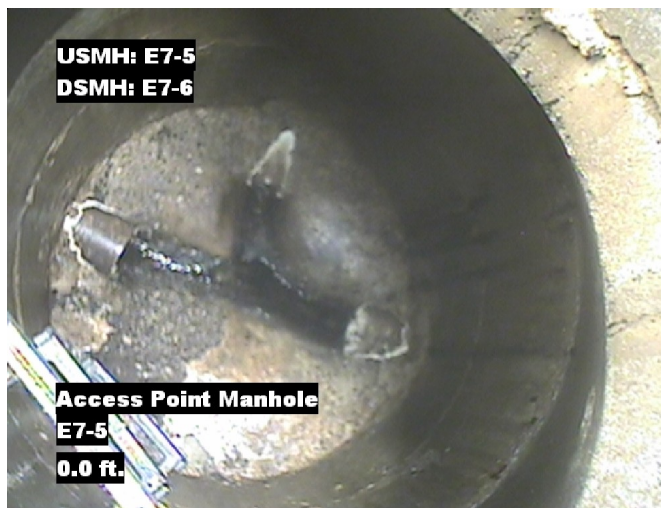
Distance: 0.0 ft. Grade: 0  
Condition: Access Point Manhole  
Remarks: E7-5

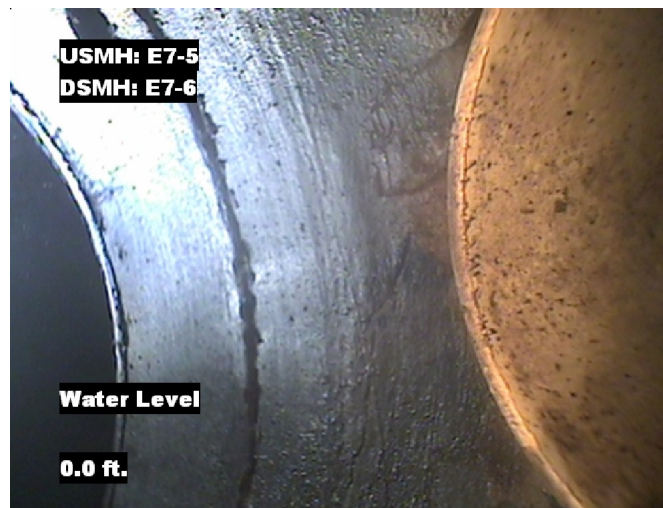
Distance: 0.0 ft. Grade: 0  
Condition: Water Level  
Remarks: N/A

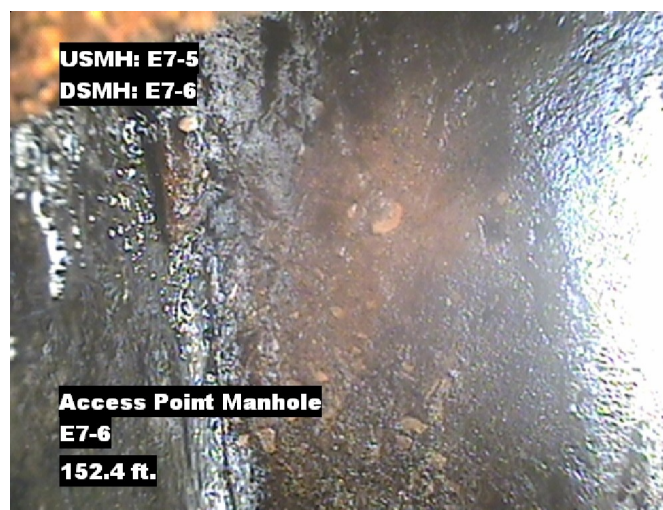
Distance: 152.4 ft. Grade: 0  
Condition: Access Point Manhole  
Remarks: E7-6
