## Defect Listing

Pipe Segment Refere... <b>E7-6_E6-5</b>	City <b>Oliver Springs</b>	Street <b>Parking Lot</b>	Material <b>PolyVinyl Chloride</b>	Location C... <b>Parking Lo...</b>	Sewer Use <b>Sanitary</b>
Upstream MH <b>E7-6</b>	Total Length <b>311.1</b>	Year Laid	Shape <b>Circular</b>	Location Details <b>Off Hwy 61</b>	
DS Manhole <b>E6-5</b>	Length surveyed <b>311.1</b>	Year Renewed	Height <b>8</b>	Width <b>8</b>	Pipe Joint... <b>13</b>

SPR <b>3</b>	MPR <b>10</b>	PO Number <b>4397-03</b>	Customer <b>GRW</b>
SPRI <b>3</b>	MPRI <b>2.5</b>	Work Order <b>4397-02</b>	Purpose <b>Pre-Rehabilitation Survey</b>
QSR <b>3100</b>	QMR <b>4123</b>		
OPR <b>13</b>	Surveyed By <b>Barry Rogers</b>	Direction <b>Downstream</b>	Date <b>20150615</b>
OPRI <b>2.6</b>	Certificate Number <b>U-1012-16405</b>	Pre-Cleaning <b>No Pre-Cleaning</b>	Time <b>14:12</b>
	Date Cleaned	End Time <b>14:37</b>	Weather <b>Very Dry</b>
			Media label
			Additional Info

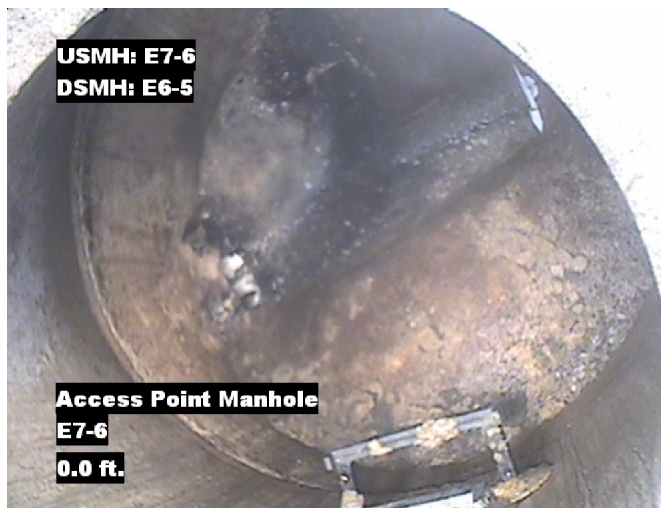
Distance: 0.0 ft. Grade: 0  
Condition: Access Point Manhole  
Remarks: E7-6

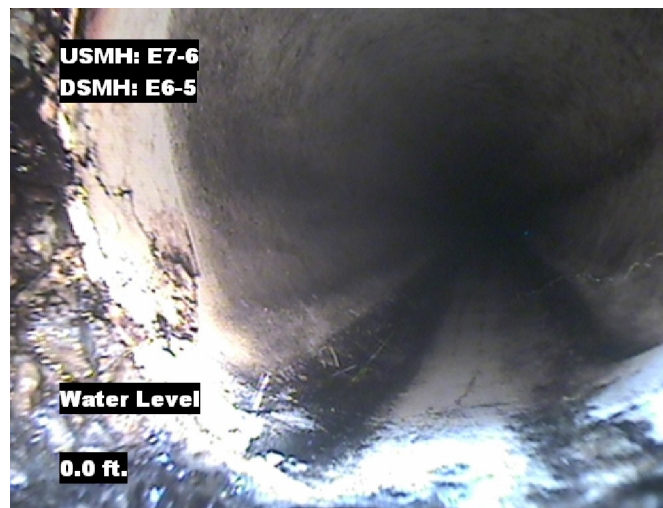
Distance: 0.0 ft. Grade: 0  
Condition: Water Level  
Remarks: N/A

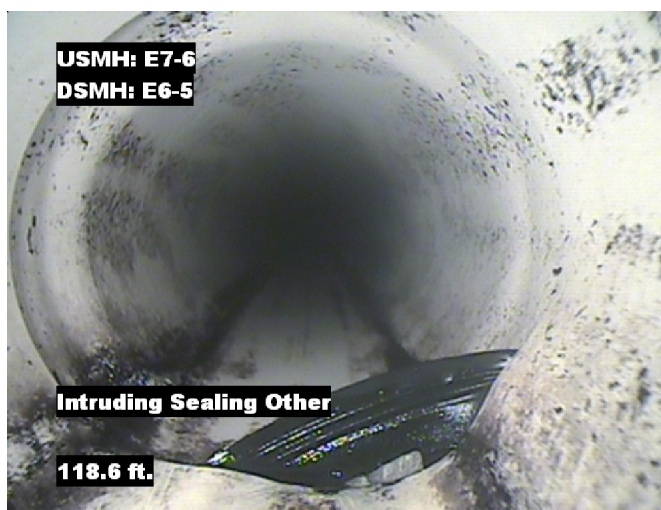
Distance: 118.6 ft. Grade: 2  
Condition: Intruding Sealing Other  
Remarks: N/A

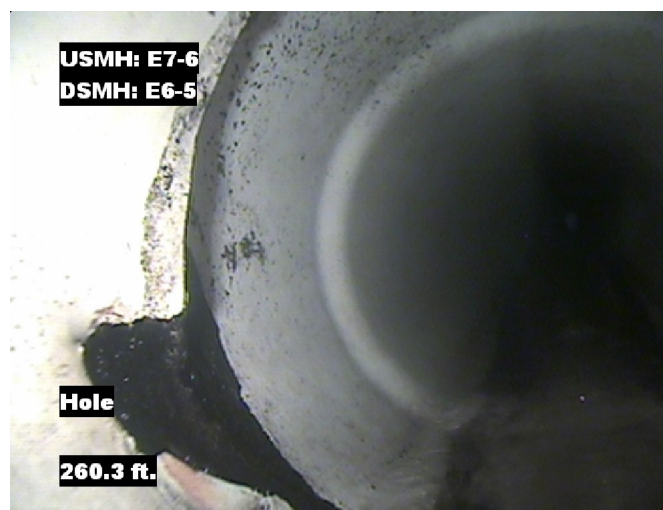
Distance: 260.3 ft. Grade: 3  
Condition: Hole  
Remarks: N/A

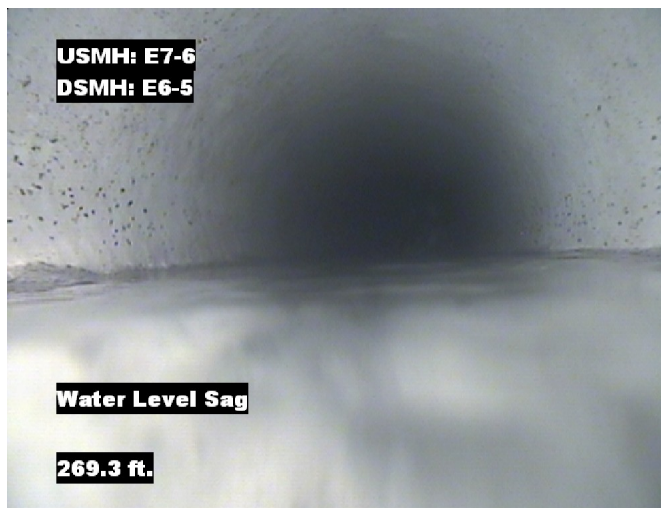
Distance: 269.3 ft. Grade: 2  
Condition: Water Level Sag  
Remarks: N/A

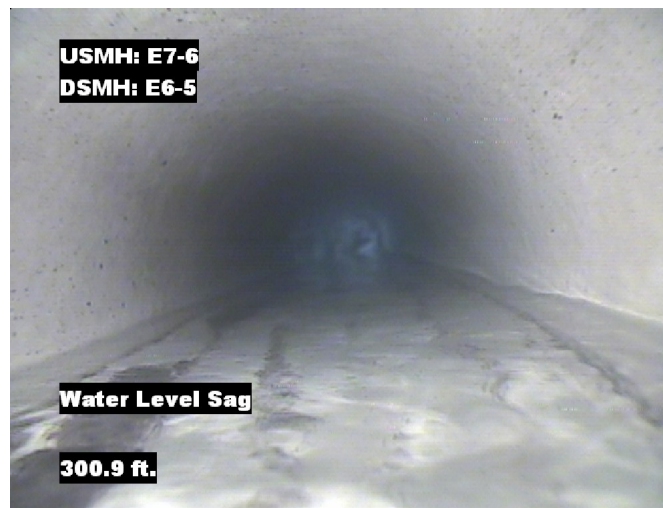
Distance: 300.9 ft. Grade: 2  
Condition: Water Level Sag  
Remarks: N/A

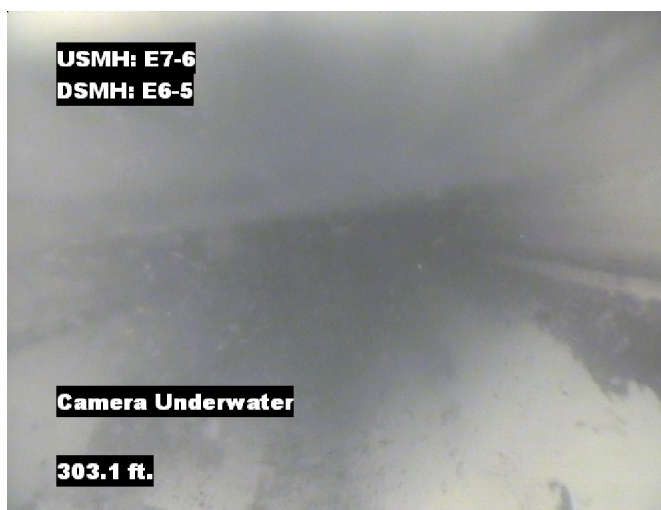
Distance: 303.1 ft. Grade: 4  
Condition: Camera Underwater  
Remarks: N/A

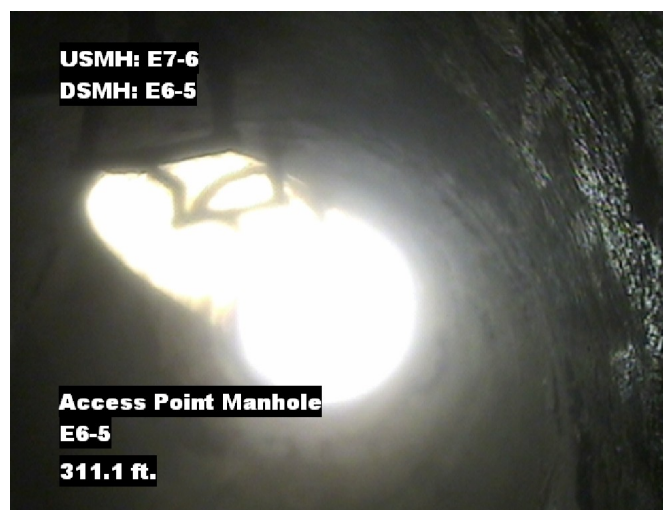
Distance: 311.1 ft. Grade: 0  
Condition: Access Point Manhole  
Remarks: E6-5
