Defect Listing

Pipe Segment Refere... E8-1_E6-5	City Oliver Springs	Street Hwy 61	Material PolyVinyl Chloride	Location C... Parking Lo...	Sewer Use Sanitary
Upstream MH E8-1	Total Length 317.2	Year Laid	Shape Circular	Location Details Church Parking Lot	
DS Manhole E6-5	Length surveyed 317.2	Year Renewed	Height 8	Width 8	Pipe Joint... 13

Image Report 4/Page

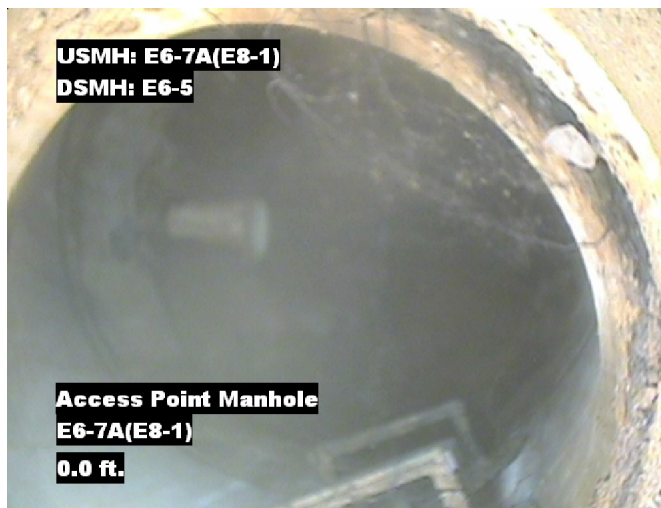
Distance: 0.0 ft. Grade: 0
Condition: Access Point Manhole
Remarks: E8-1

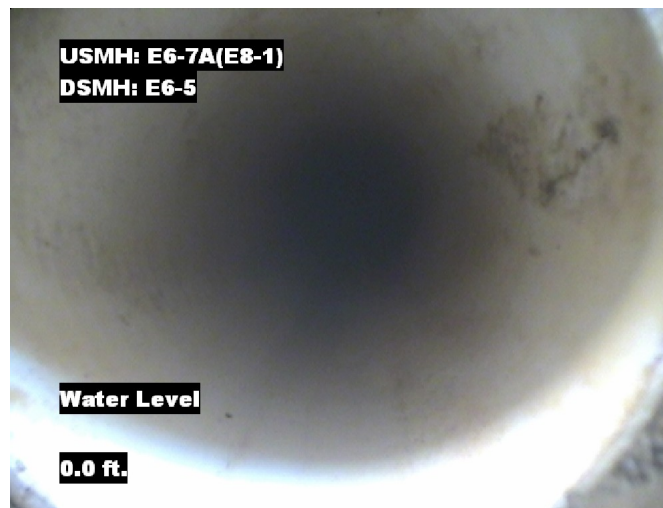
Distance: 0.0 ft. Grade: 0
Condition: Water Level
Remarks: N/A

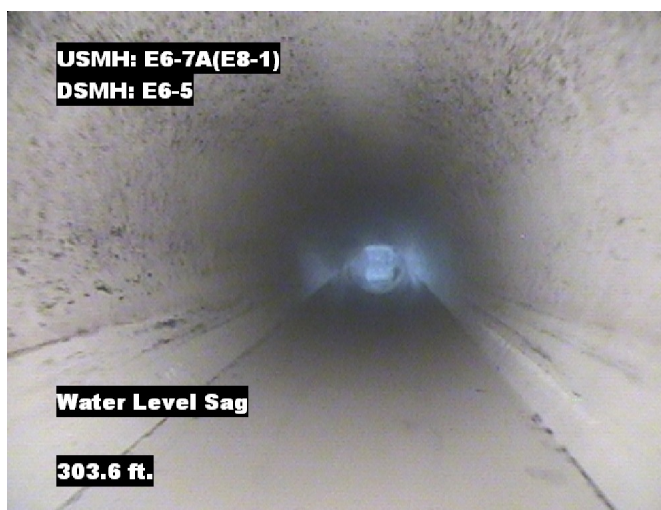
Distance: 303.6 ft. Grade: 2
Condition: Water Level Sag
Remarks: N/A

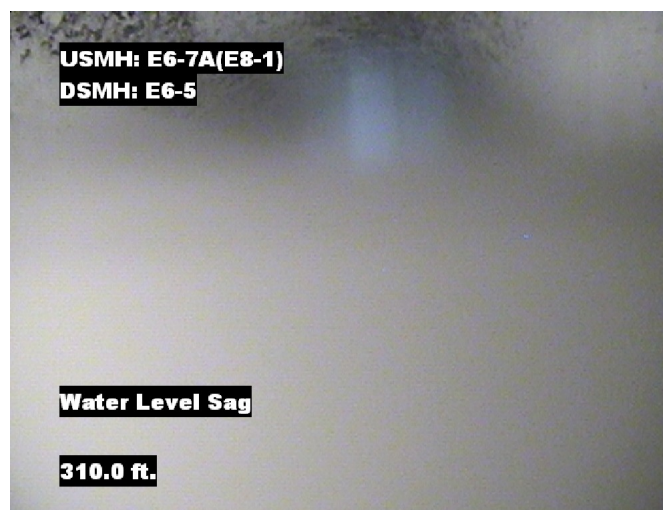
Distance: 310.0 ft. Grade: 2
Condition: Water Level Sag
Remarks: N/A

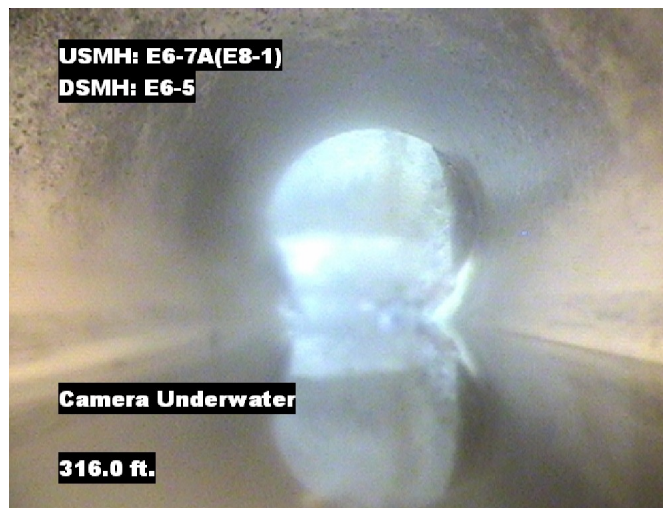
Distance: 316.0 ft. Grade: 4
Condition: Camera Underwater
Remarks: N/A

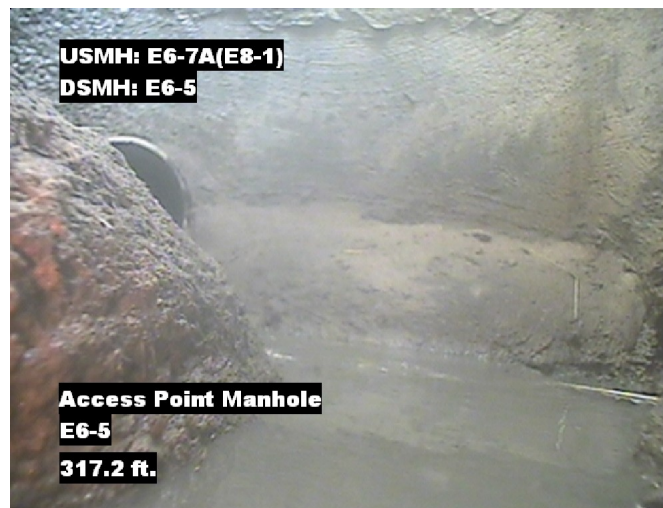
Distance: 317.2 ft. Grade: 0
Condition: Access Point Manhole
Remarks: E6-5
