## Defect Listing

Pipe Segment Refere... <b>E9-1_E6-3</b>	City <b>Oliver Springs</b>	Street <b>Gail Ln</b>	Material <b>PolyVinyl Chloride</b>	Location C... <b>Light High...</b>	Sewer Use <b>Sanitary</b>
Upstream MH <b>E9-1</b>	Total Length <b>299.8</b>	Year Laid	Shape <b>Circular</b>	Location Details <b>Street</b>	
DS Manhole <b>E6-3</b>	Length surveyed <b>299.8</b>	Year Renewed	Height <b>8</b>	Width <b>8</b>	Pipe Joint... <b>13</b>

SPR <b>3</b>	MPR <b>4</b>	PO Number <b>4397-03</b>	Customer <b>GRW</b>
SPRI <b>3</b>	MPRI <b>2</b>	Work Order <b>4397-02</b>	Purpose <b>Pre-Rehabilitation Survey</b>
QSR <b>3100</b>	QMR <b>2200</b>		
OPR <b>7</b>	Surveyed By <b>Barry Rogers</b>	Direction <b>Downstream</b>	Date <b>20150616</b>
OPRI <b>2.3</b>	Certificate Number <b>U-1012-16405</b>	Pre-Cleaning <b>No Pre-Cleaning</b>	Time <b>14:26</b>
	Date Cleaned	End Time <b>14:45</b>	Weather <b>Very Dry</b>
			Media label
			Additional Info

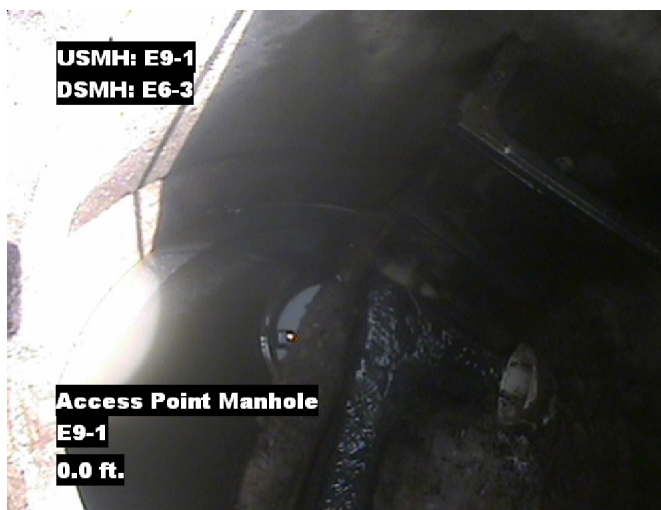
Distance: 0.0 ft. Grade: 0  
Condition: Access Point Manhole  
Remarks: E9-1

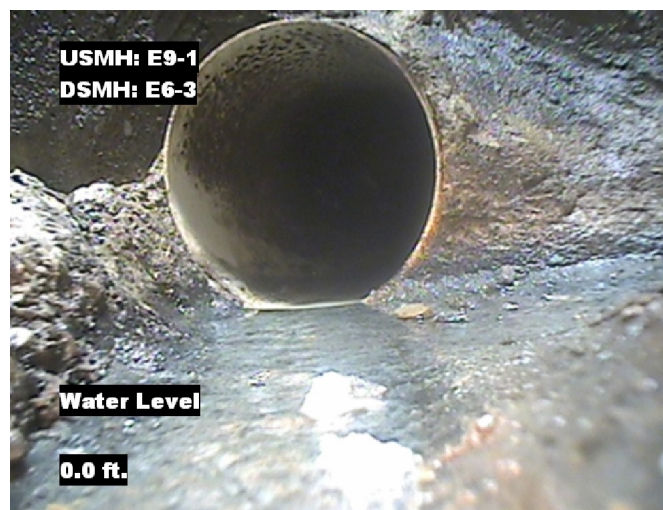
Distance: 0.0 ft. Grade: 0  
Condition: Water Level  
Remarks: N/A

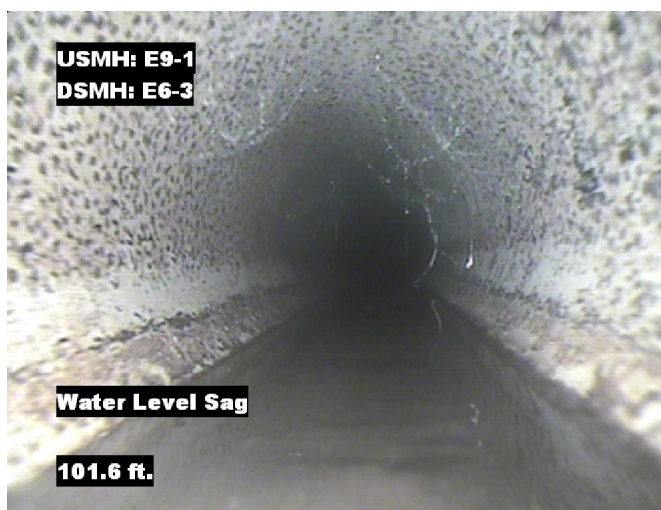
Distance: 101.5 ft. Grade: 2  
Condition: Water Level Sag  
Remarks: N/A

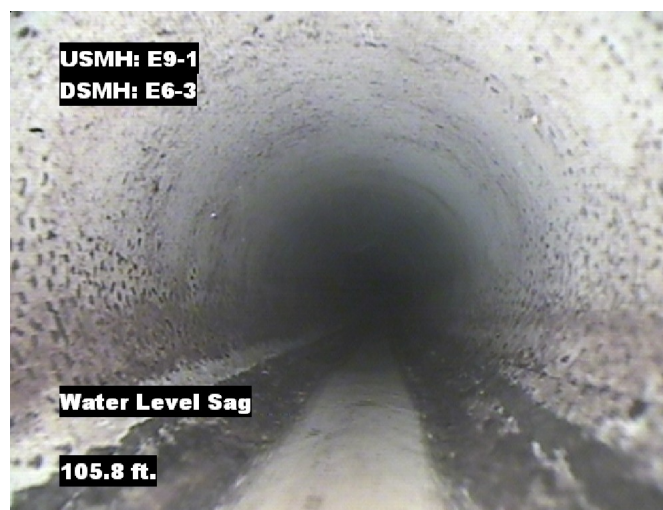
Distance: 105.8 ft. Grade: 2  
Condition: Water Level Sag  
Remarks: N/A

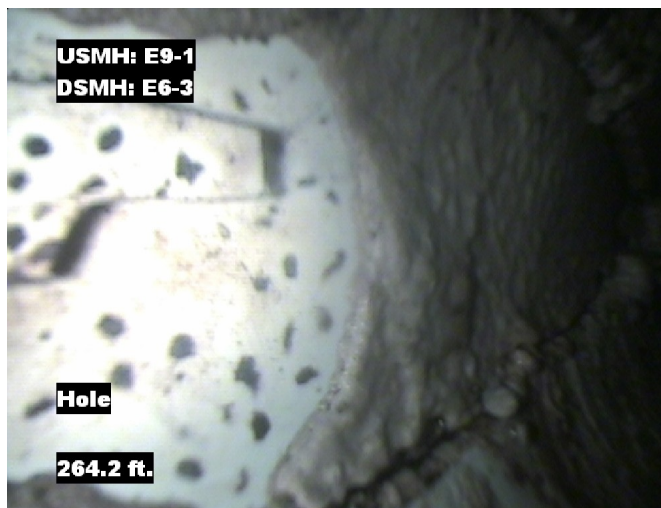
Distance: 264.2 ft. Grade: 3  
Condition: Hole  
Remarks: N/A

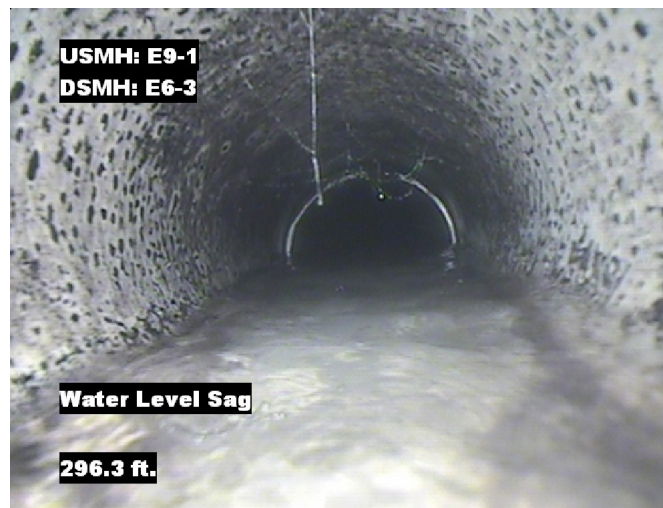
Distance: 296.3 ft. Grade: 2  
Condition: Water Level Sag  
Remarks: N/A

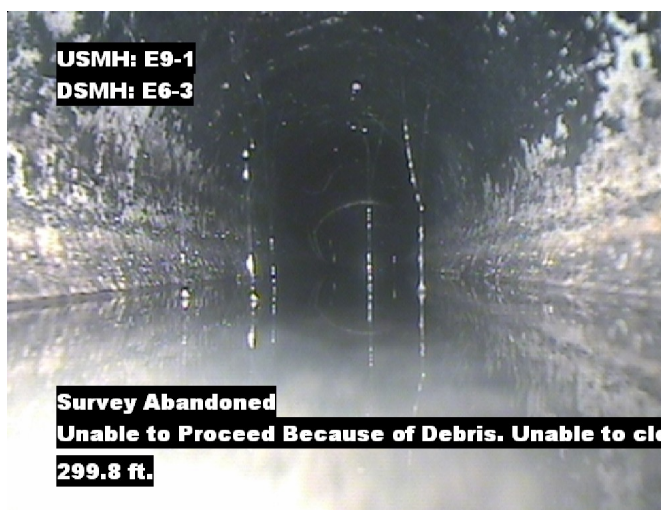
Distance: 299.8 ft. Grade: 0  
Condition: Survey Abandoned  
Remarks: Unable to Proceed Because of Debris.  
Unable to clean because of Down Stream
