Defect Listing

Pipe Segment Refere... E9-2 E9-1	City Oliver Springs	Street Gail Ln	Material PolyVinyl Chloride	Location C... Light High...	Sewer Use Sanitary
Upstream MH E9-2	Total Length 234.7	Year Laid	Shape Circular	Location Details Street	
DS Manhole E9-1	Length surveyed 234.7	Year Renewed	Height 8	Width 8	Pipe Joint... 13

Image Report 4/Page

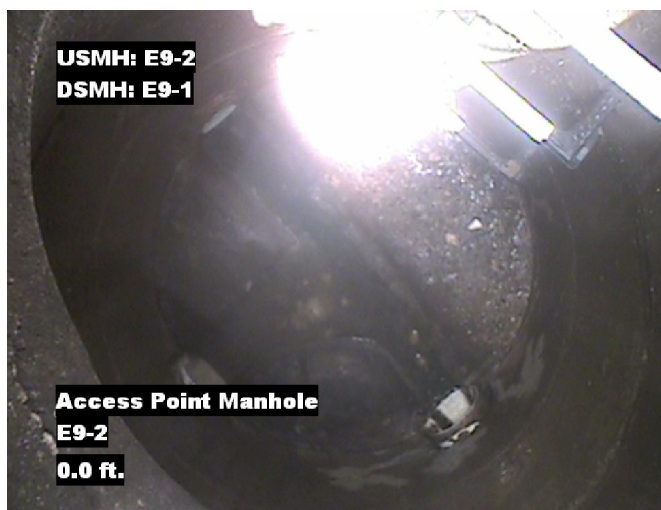
Distance: 0.0 ft. Grade: 0
Condition: Access Point Manhole
Remarks: E9-2

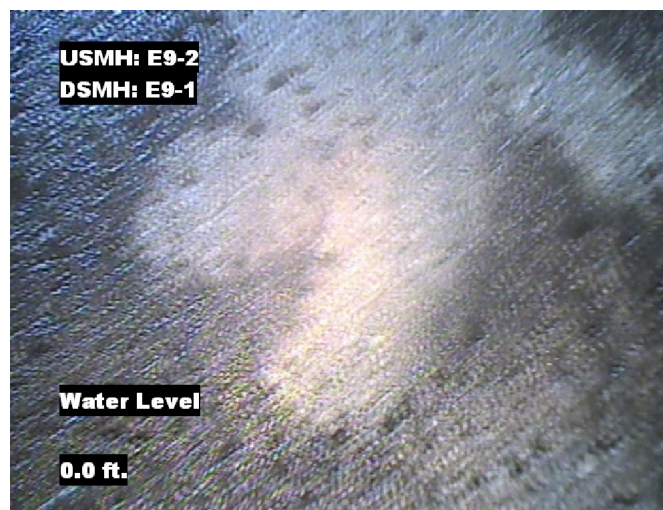
Distance: 0.0 ft. Grade: 0
Condition: Water Level
Remarks: N/A

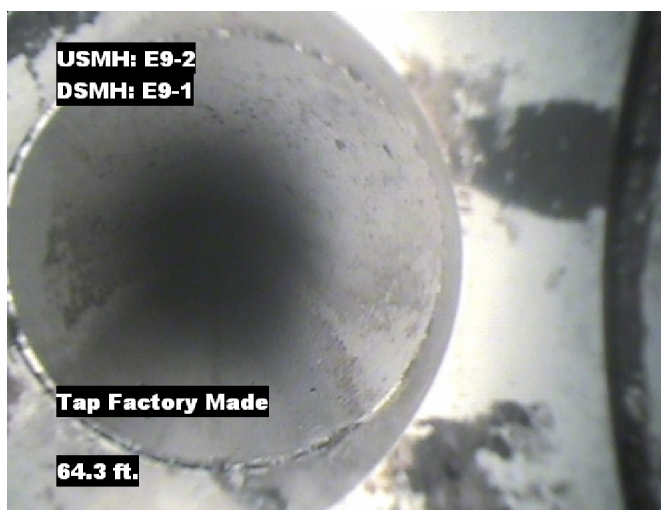
Distance: 64.3 ft. Grade: 0
Condition: Tap Factory Made
Remarks: N/A

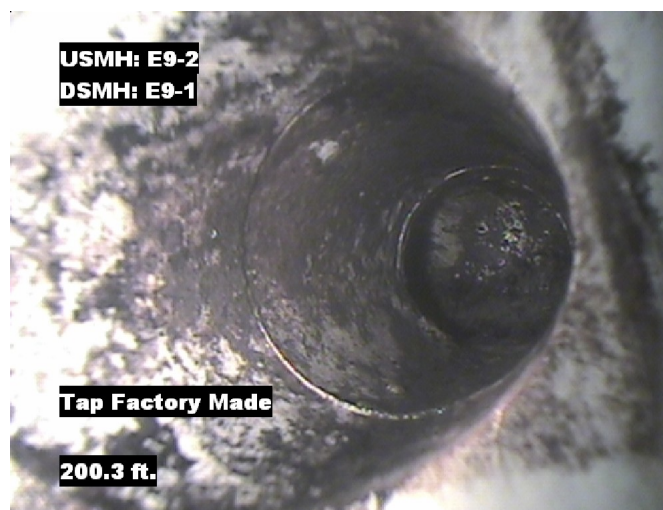
Distance: 200.3 ft. Grade: 0
Condition: Tap Factory Made
Remarks: N/A

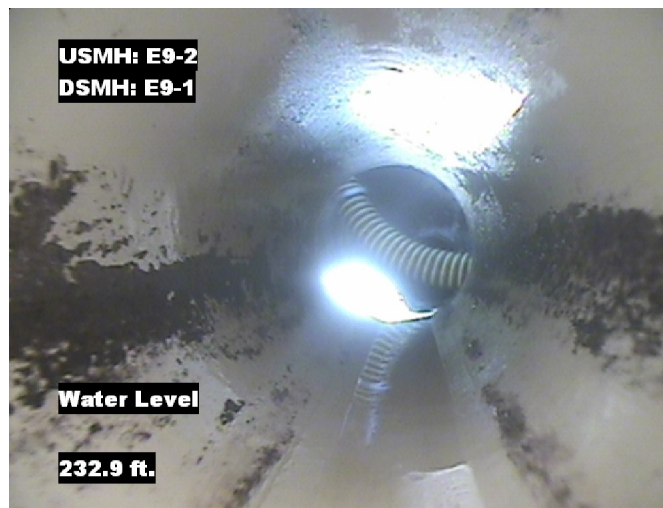
Distance: 232.8 ft. Grade: 0
Condition: Water Level
Remarks: N/A

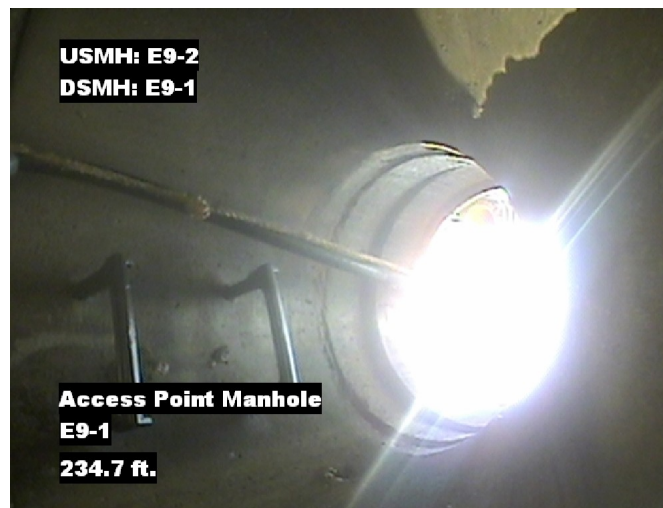
Distance: 234.7 ft. Grade: 0
Condition: Access Point Manhole
Remarks: E9-1
