## Defect Listing

Pipe Segment Refere... <b>E9-3_E9-2</b>	City <b>Oliver Springs</b>	Street <b>Gail Ln</b>	Material <b>PolyVinyl Chloride</b>	Location C... <b>Light High...</b>	Sewer Use <b>Sanitary</b>
Upstream MH <b>E9-3</b>	Total Length <b>247.5</b>	Year Laid	Shape <b>Circular</b>	Location Details <b>Apartment Complex</b>	
DS Manhole <b>E9-2</b>	Length surveyed <b>247.5</b>	Year Renewed	Height <b>8</b>	Width <b>8</b>	Pipe Joint... <b>13</b>

SPR <b>N/A</b>	MPR <b>14</b>	PO Number <b>4397-03</b>	Customer <b>GRW</b>
SPRI <b>N/A</b>	MPRI <b>3.5</b>	Work Order <b>4397-02</b>	Purpose <b>Pre-Rehabilitation Survey</b>
QSR <b>N/A</b>	QMR <b>4321</b>		
OPR <b>14</b>	Surveyed By <b>Barry Rogers</b>	Direction <b>Downstream</b>	Date <b>20150616</b>
OPRI <b>3.5</b>	Certificate Number <b>U-1012-16405</b>	Pre-Cleaning <b>Jetting</b>	Time <b>12:08</b>
	Date Cleaned <b>20150616</b>	End Time <b>12:26</b>	Weather <b>Very Dry</b>
			Media label
			Additional Info

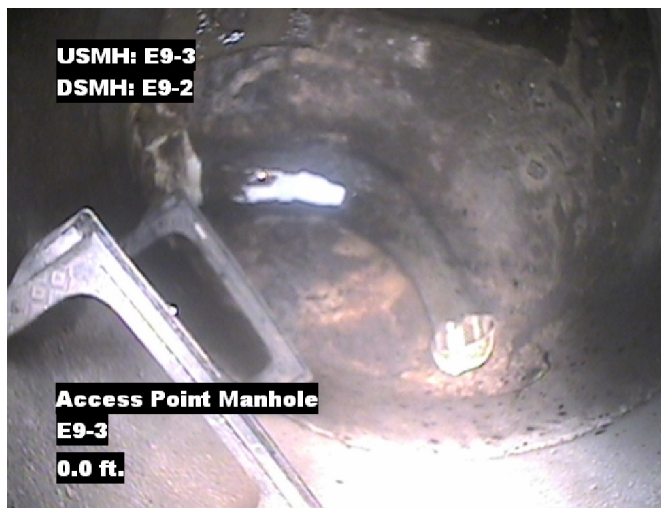
Distance: 0.0 ft. Grade: 0  
Condition: Access Point Manhole  
Remarks: E9-3

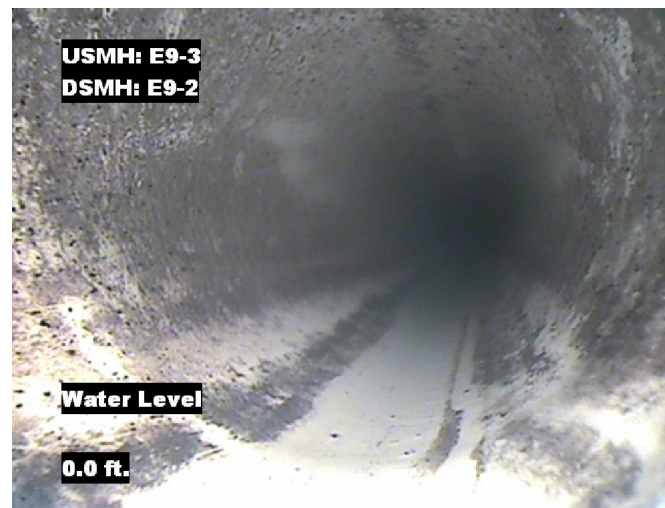
Distance: 0.0 ft. Grade: 0  
Condition: Water Level  
Remarks: N/A

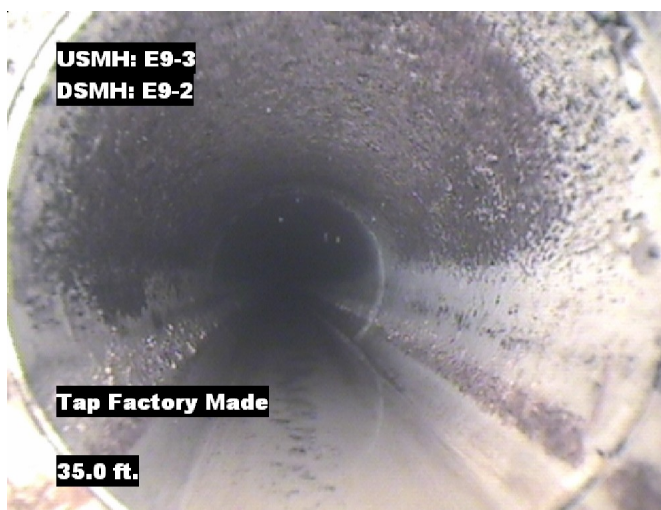
Distance: 35.0 ft. Grade: 0  
Condition: Tap Factory Made  
Remarks: N/A

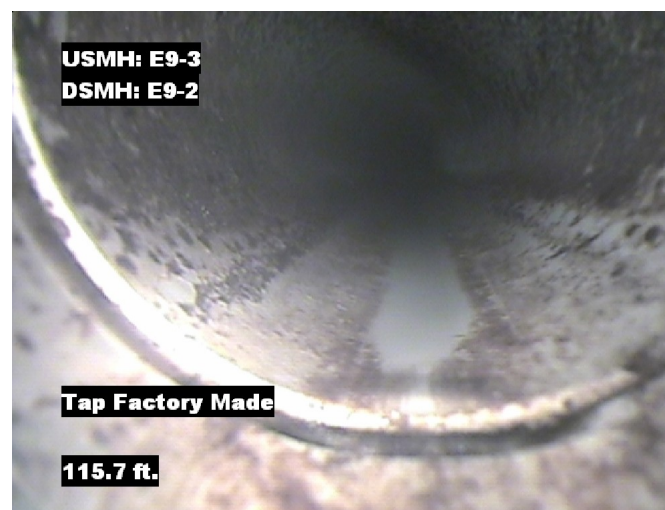
Distance: 115.7 ft. Grade: 0  
Condition: Tap Factory Made  
Remarks: N/A

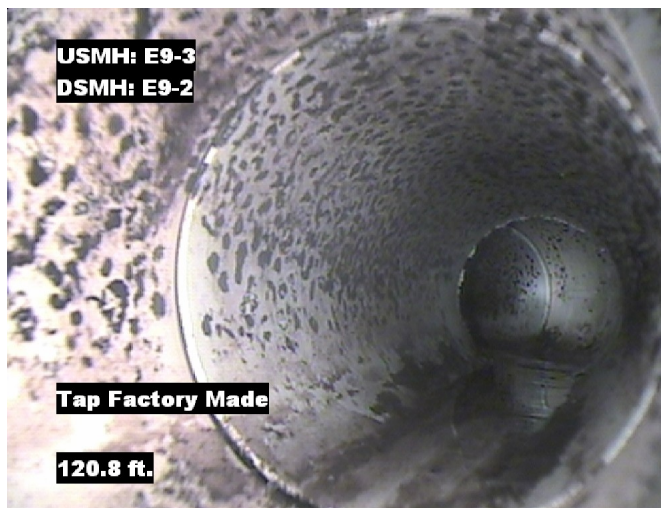
Distance: 120.8 ft. Grade: 0  
Condition: Tap Factory Made  
Remarks: N/A

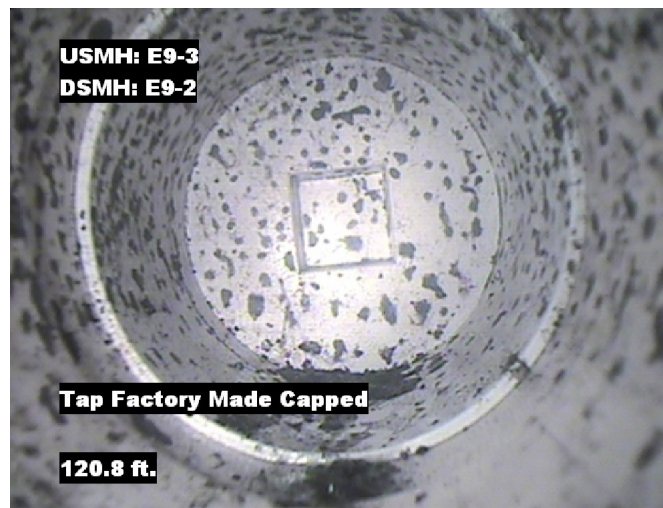
Distance: 120.8 ft. Grade: 0  
Condition: Tap Factory Made Capped  
Remarks: N/A

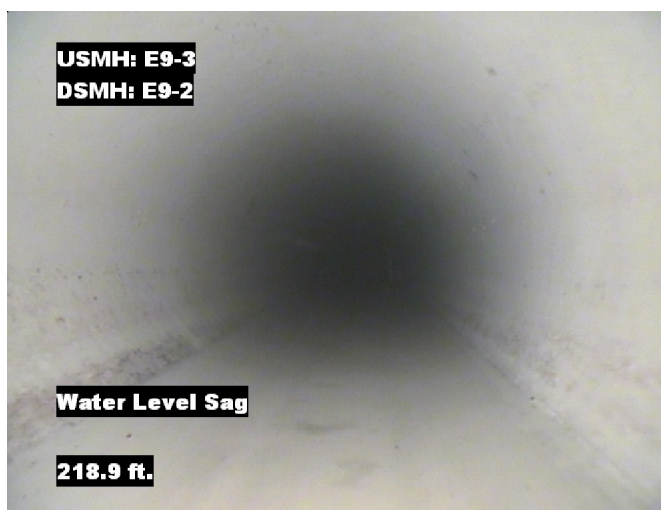
Distance: 218.9 ft. Grade: 2  
Condition: Water Level Sag  
Remarks: N/A

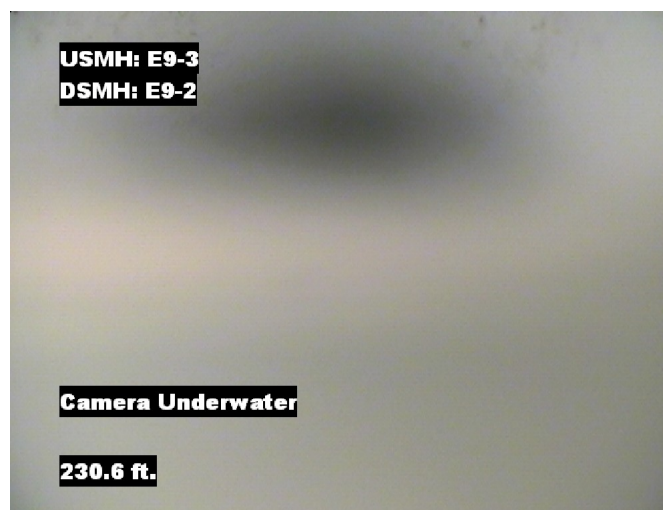
Distance: 230.6 ft. Grade: 4  
Condition: Camera Underwater  
Remarks: N/A

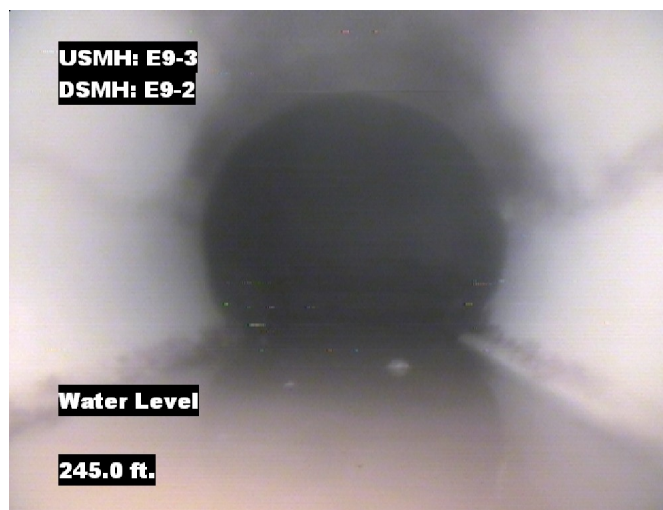
Distance: 245.0 ft. Grade: 0  
Condition: Water Level  
Remarks: N/A

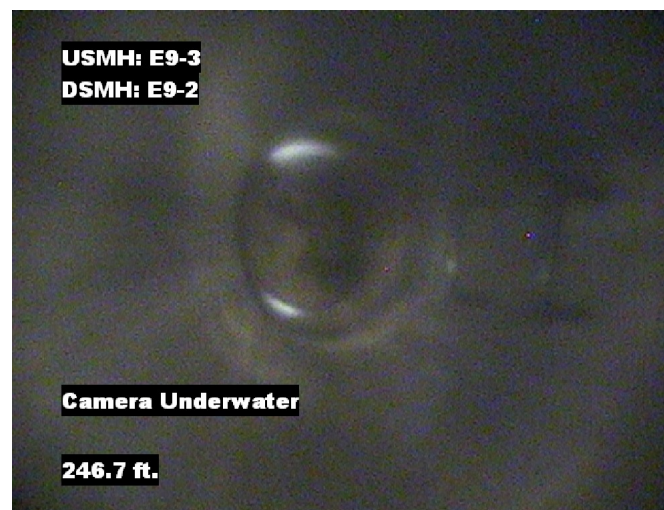
Distance: 246.6 ft. Grade: 4  
Condition: Camera Underwater  
Remarks: N/A

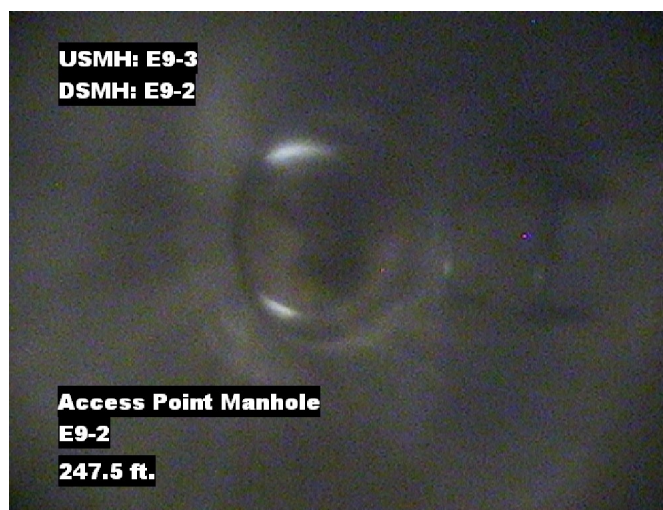
Distance: 247.5 ft. Grade: 0  
Condition: Access Point Manhole  
Remarks: E9-2
