Defect Listing

Pipe Segment Refere... E9-4_E9-1	City Oliver Springs	Street Gail Ln	Material PolyVinyl Chloride	Location C... Light High...	Sewer Use Sanitary
Upstream MH E9-4	Total Length 171.1	Year Laid	Shape Circular	Location Details Street	
DS Manhole E9-1	Length surveyed 171.1	Year Renewed	Height 8	Width 8	Pipe Joint... 13

SPR N/A	MPR N/A	PO Number 4397-03		Customer GRW	
SPRI N/A	MPRI N/A	Work Order 4397-02		Purpose Pre-Rehabilitation Survey	
QSR N/A	QMR N/A				
OPR N/A	Surveyed By Barry Rogers	Direction Upstream	Date 20150616	Media label	
OPRI N/A	Certificate Number U-1012-16405	Pre-Cleaning Jetting	Time 13:50	Weather Very Dry	
Date Cleaned 20150616			End Time 14:11	Additional Info

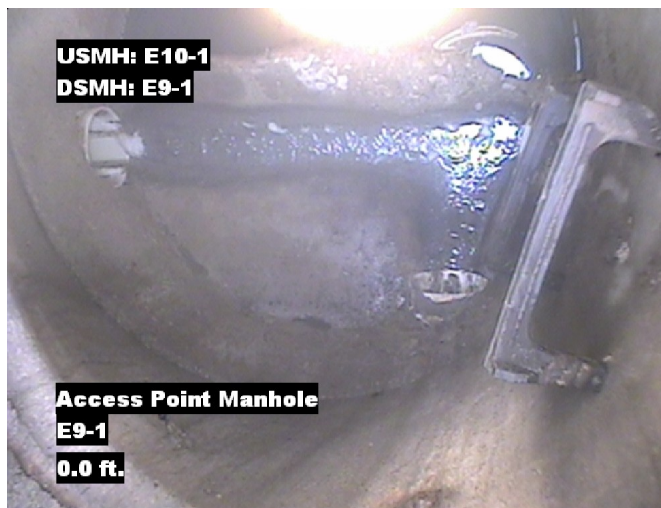
Distance: 0.0 ft. Grade: 0
Condition: Access Point Manhole
Remarks: E9-1

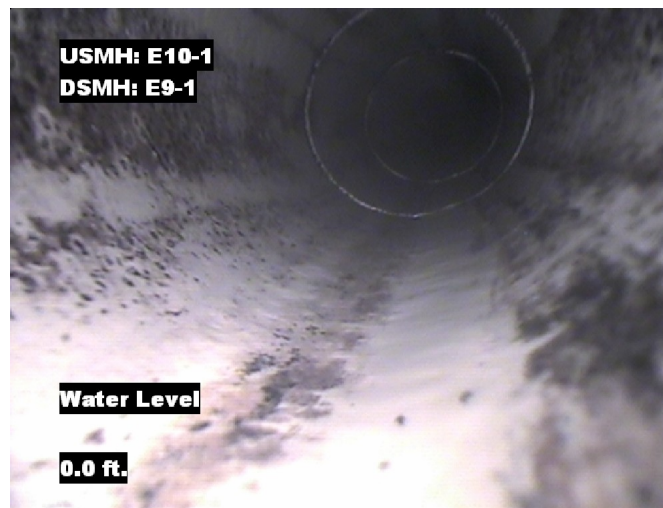
Distance: 0.0 ft. Grade: 0
Condition: Water Level
Remarks: N/A

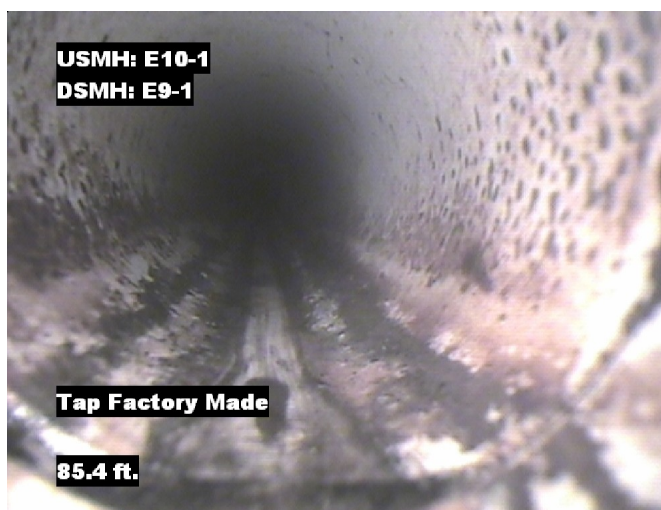
Distance: 85.4 ft. Grade: 0
Condition: Tap Factory Made
Remarks: N/A

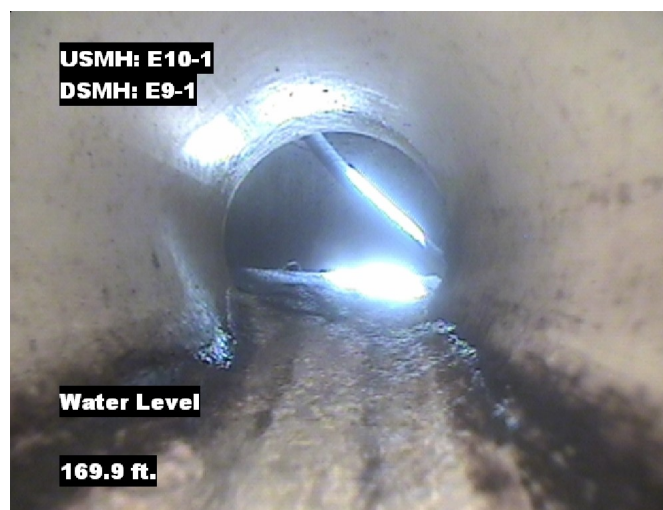
Distance: 169.8 ft. Grade: 0
Condition: Water Level
Remarks: N/A

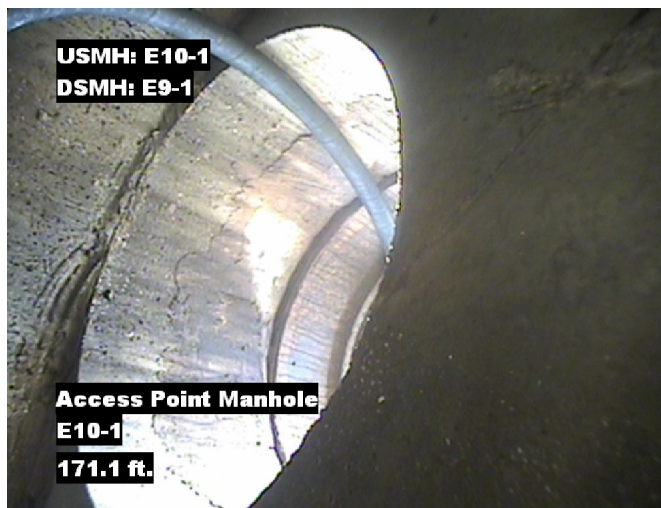
Distance: 171.1 ft. Grade: 0
Condition: Access Point Manhole
Remarks: E9-4
