Defect Listing

Pipe Segment Refere... EoID20-8_D20-8	City Oliver Springs	Street Airport rd	Material PolyVinyl Chloride	Location C... Easement/R...	Sewer Use Sanitary
Upstream MH EoID20-8	Total Length 132.4	Year Laid	Shape Circular	Location Details Side of RD @ Culde ...	
DS Manhole D20-8	Length surveyed 132.4	Year Renewed	Height 8	Width 8	Pipe Joint... 13

SPR N/A	MPR 3	PO Number 4397-03	Customer GRW
SPRI N/A	MPRI 1.5	Work Order 4397-02	Purpose Pre-Rehabilitation Survey
QSR N/A	QMR 2111		
OPR 3	Surveyed By Barry Rogers	Direction Upstream	Date 20150601
OPRI 1.5	Certificate Number U-1012-16405	Pre-Cleaning No Pre-Cleaning	Time 15:19
	Date Cleaned	End Time 15:33	Weather Damp
		Additional Info

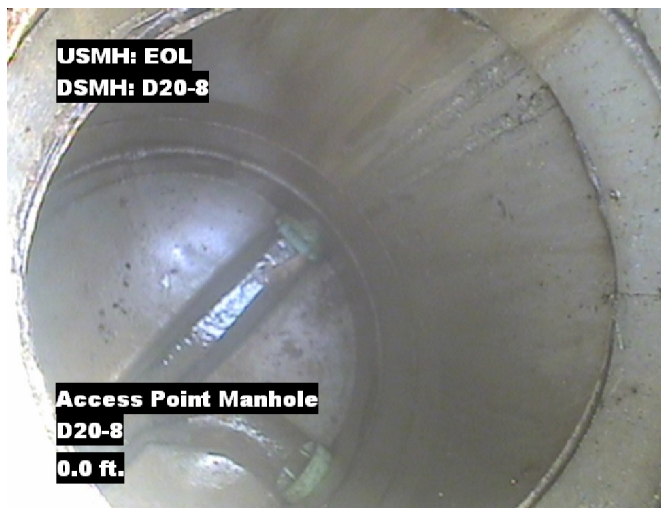
Distance: 0.0 ft. Grade: 0
Condition: Access Point Manhole
Remarks: D20-8

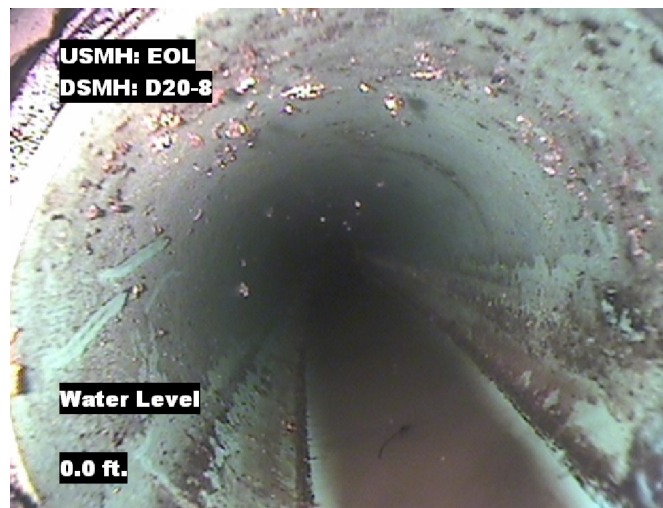
Distance: 0.0 ft. Grade: 0
Condition: Water Level
Remarks: N/A

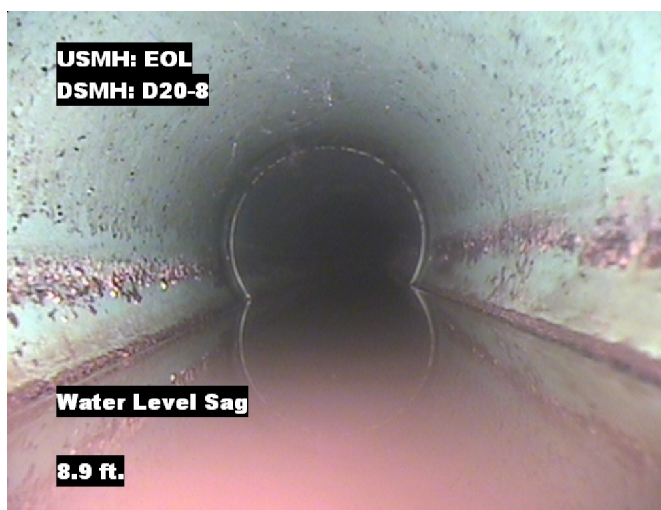
Distance: 8.9 ft. Grade: 2
Condition: Water Level Sag
Remarks: N/A

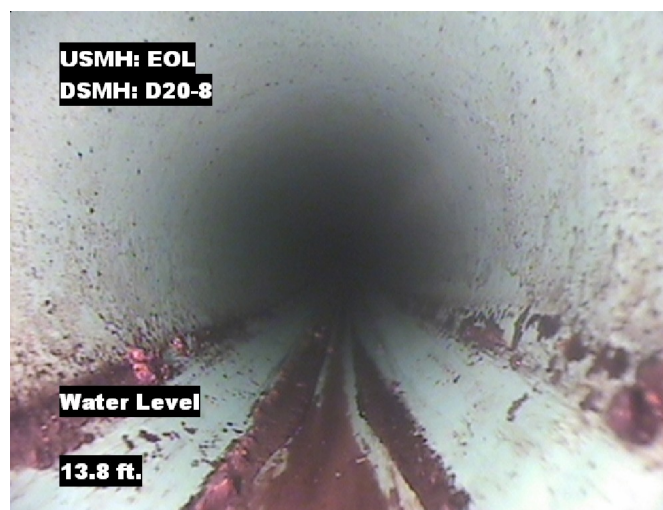
Distance: 13.8 ft. Grade: 0
Condition: Water Level
Remarks: N/A

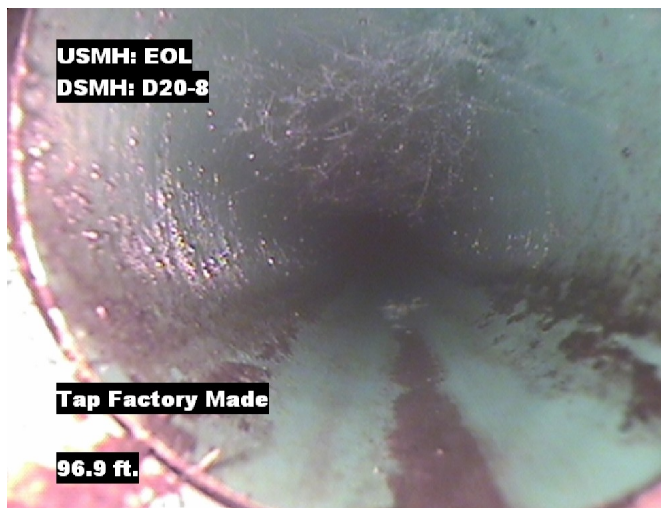
Distance: 96.9 ft. Grade: 0
Condition: Tap Factory Made
Remarks: N/A

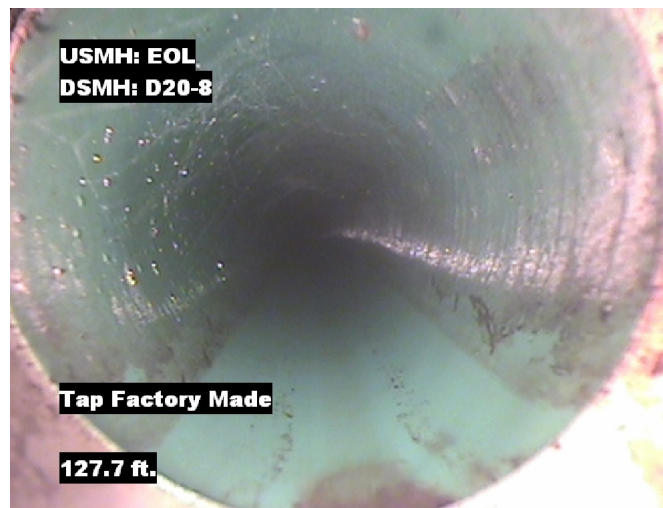
Distance: 127.7 ft. Grade: 0
Condition: Tap Factory Made
Remarks: N/A

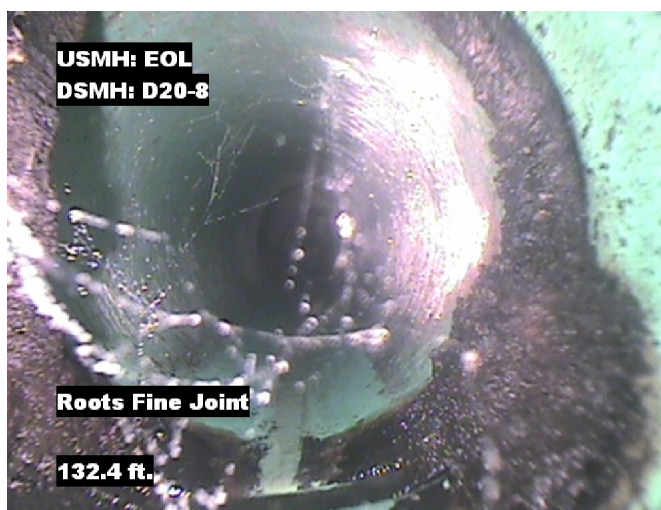
Distance: 132.4 ft. Grade: 1
Condition: Roots Fine Joint
Remarks: N/A

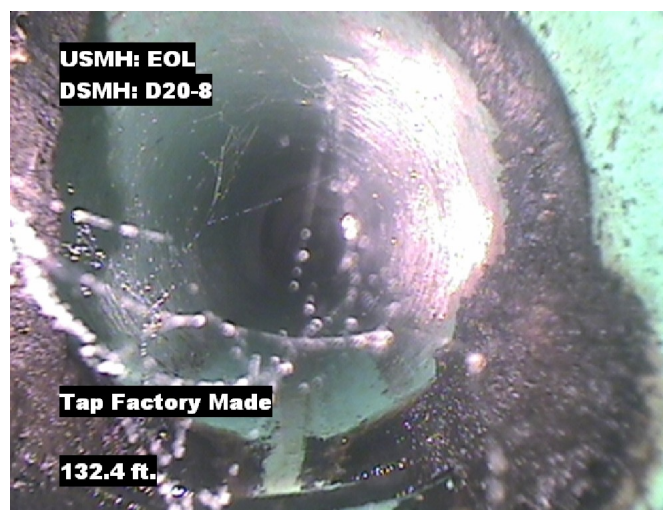
Distance: 132.4 ft. Grade: 0
Condition: Tap Factory Made
Remarks: N/A

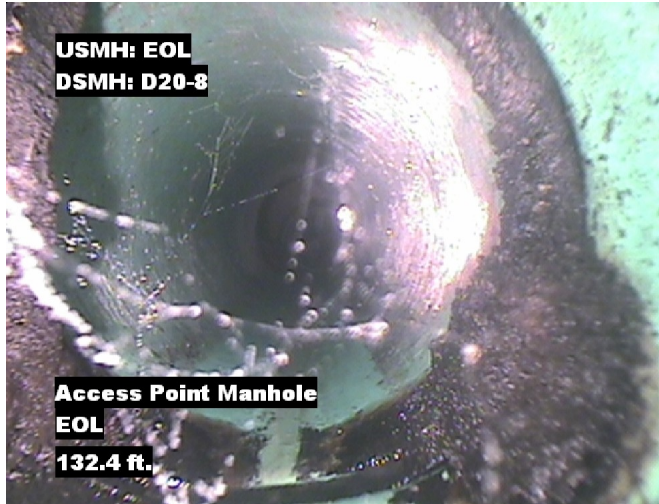
Distance: 132.4 ft. Grade: 0
Condition: Access Point Manhole
Remarks: EOL D20-8
